Reay Creek Fish and Fish Habitat Assessment 2018

Town of Sidney
c/o Tim Tanton, Director of Development Services, Engineering, Parks and Public Works
2440 Sidney Avenue
Sidney, BC, V8L 1Y7

July 2018

EXECUTIVE SUMMARY AND RECOMMENDATIONS

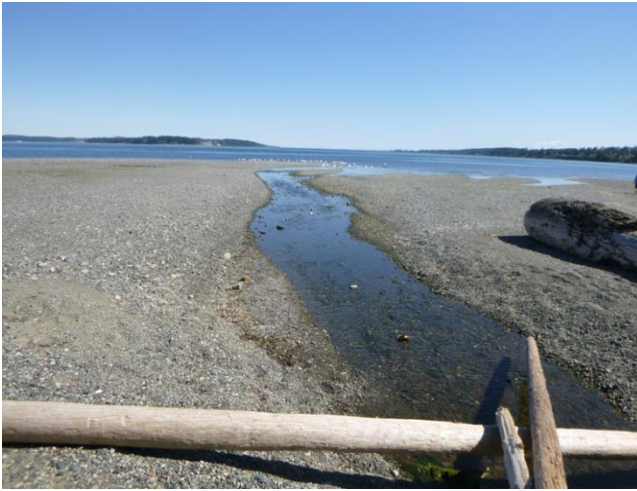
Photo 1. Reach-0: Looking downstream at Reay Creek draining into Bazan Bay (May 11, 2018).

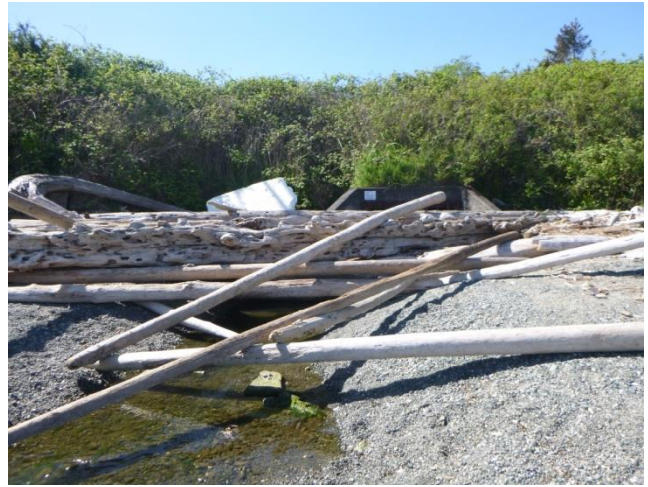
into Bazan Bay in a single channel, which is passable by anadromous salmon under low tide conditions. The creek and tidal flow is partially restricted by the concrete box culvert under Lochside Road.

Photo 2. Reach-0: Looking upstream at Reay Creek flowing out of the Lochside Drive culvert (May 11, 2018).

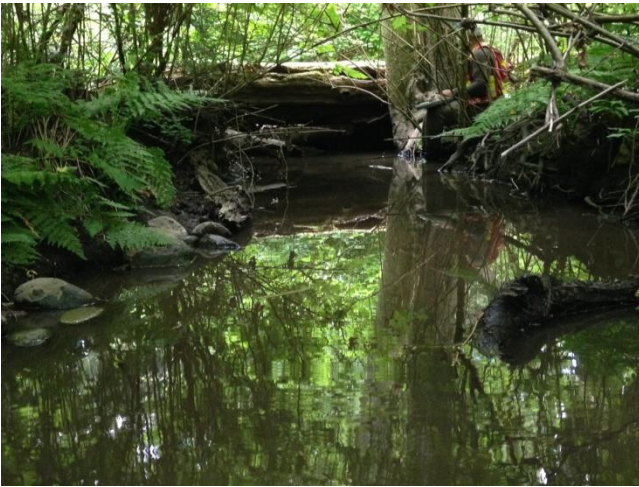
Photo 19. Reach-4 (0+751): Looking upstream at a glide habitat with a log jam (June 5, 2018).

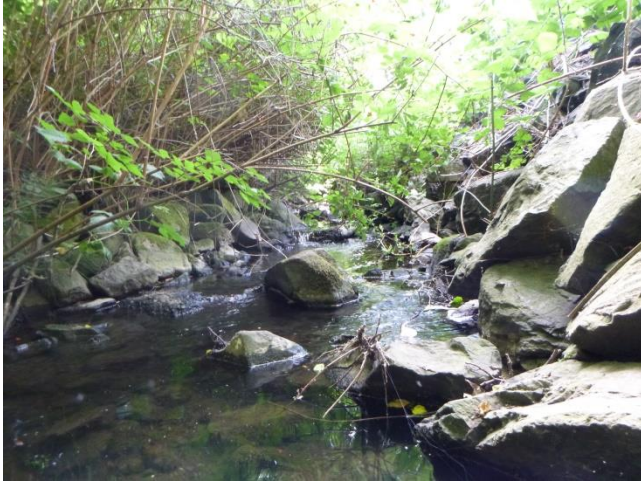
Photo 21. Reach-4 (0+844): Looking upstream at created riffle habitat at the outlet of the Pond (June 5, 2018).

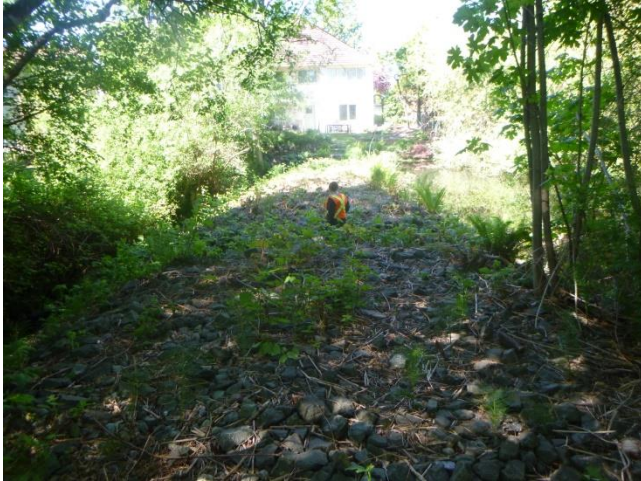
Photo 29. Reach-5 (10 U 469385 E; 5387437 N): Looking west at the Pond dam (May 11, 2018).

Should the Pond be maintained in its current state with a new dam conforming to the BC Dam Safety Regulations¹, a fish ladder should be added to allow for easy upstream and downstream dam passage especially in high-flow conditions in the fall when Coho Salmon typically ascend

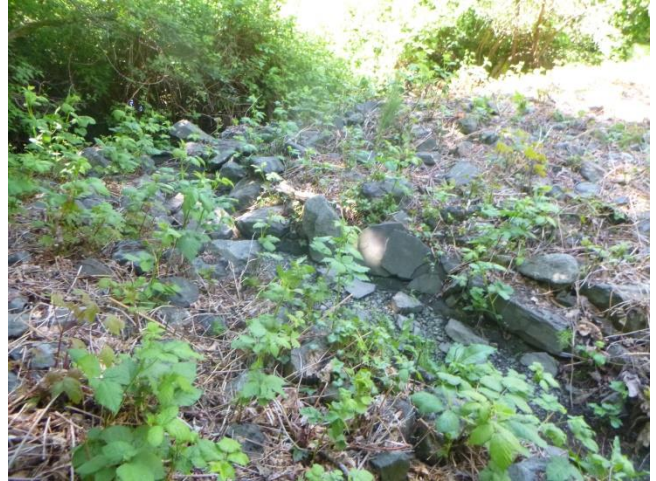
Photo 30. Reach-5 (10 U 469385 E; 5387437 N): Looking west at overflow spillway of the Pond dam (May 11, 2018).

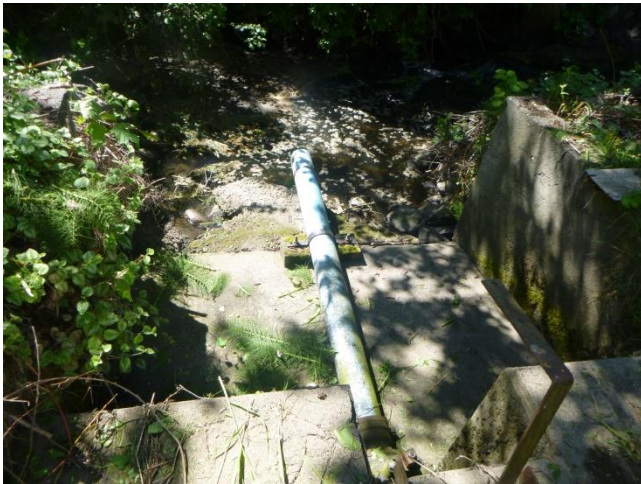
Photo 31. Reach-5 (10 U 469385 E; 5387437 N): Looking downstream at overflow spillway of the Pond dam (May 11, 2018).

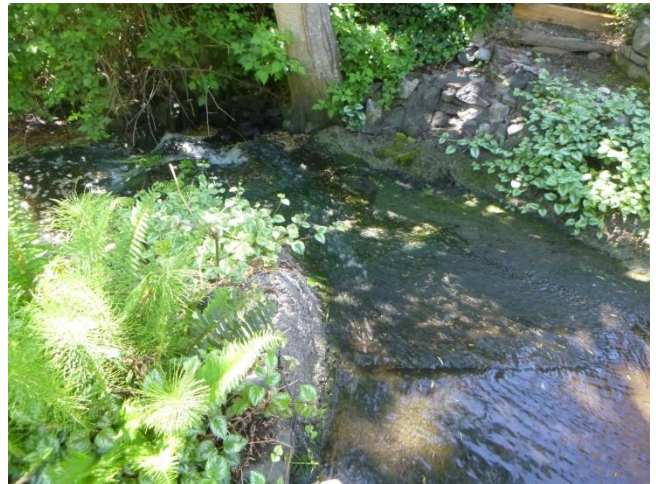
Photo 32. Reach-5 (10 U 469385 E; 5387437 N): Looking downstream at spillway of the Pond dam (May 11, 2018).

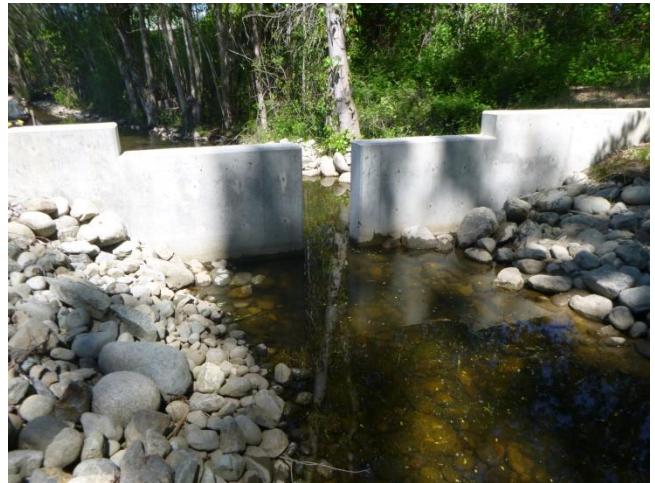
Photo 36. Reach-6 (1+350): Looking upstream at glide habitat and stormwater detention pond wall (May 11, 2018).

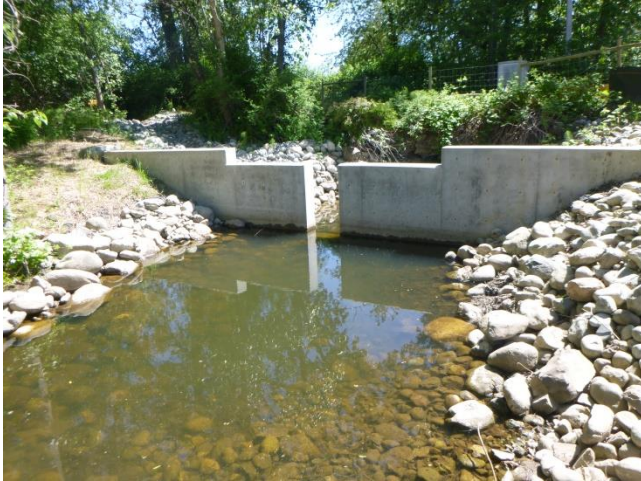
Photo 37. Reach-6 (1+379): Looking downstream at pool habitat and stormwater detention pond wall (May 11, 2018).
