Town Of Sidney Municipal Building Building Assessment Report

Project Number:
2025508

Prepared By:
Number Ten Architectural Group
200-1619 Store Street
Victoria BC V8W 3K3

Date:
2025-06-03

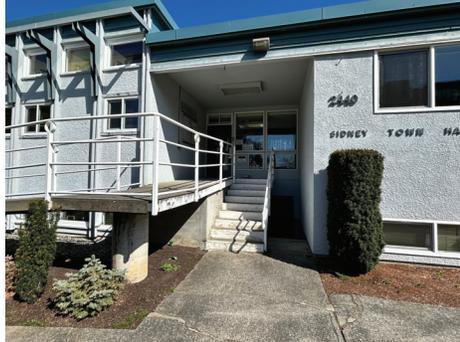
The current public building entries, to front desk and council chambers provide a crowded and uninviting access. This is partly as a result of the addition of an access ramp filling a portion of the small recession into the structure at the door. A full renovation would provide the opportunity to rework the entry, likely projecting from the front mid section of the building to create an entry lobby with one internal ramp. This would provide a defined and sophisticated entry more in keeping with a public building.

main entry

This addition would be combined with a recladding of the entire building and the opportunity to add some solar shading devices to the south exterior. The building currently experiences overheating in a number of locations. Interestingly the addition has some shading devices but only utilized in one location. A full renovation would involve replacing the minimal insulation in the walls and potentially adding exterior insulation, dependent on the results of energy modeling. Re-cladding would be required to access the structural work as well, as noted later, giving the opportunity to provide the building with a more contemporary look. Replacement of all windows would also take place to improve the current poor performance.

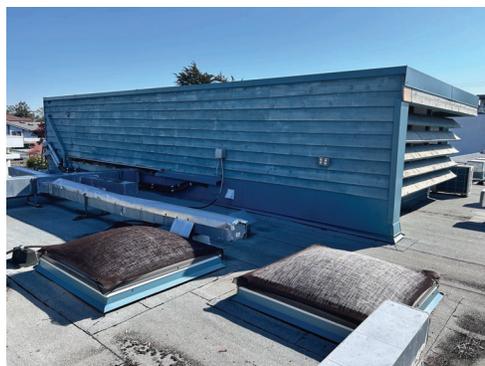
Retrofit cooling units have been installed in several area's of the building as a result of overheating from unshaded windows. This is compounded by skylights that are currently covered on the outside due to both heat and glare. The mechanical report goes into this in more detail. The issue of heat and glare occurs on the upper two levels. Inversely the basement level has relatively high small windows making the quality of the space less than ideal. Replacement of all windows would also take place to improve the current poor performance.

covered skylights

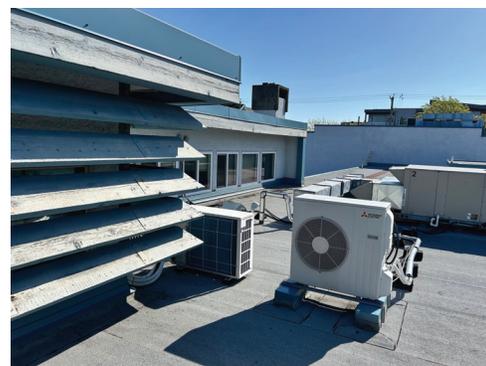
*solar shade,
windows with overheating issue beyond*

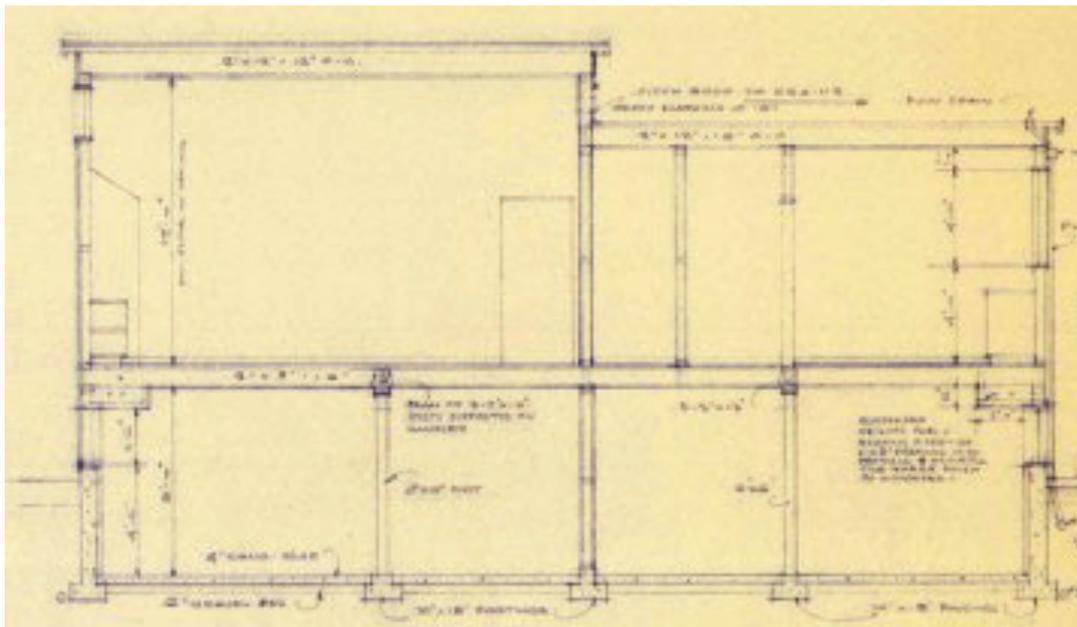
Figure 1: Building Section

This building is a conventional light wood frame structure founded on pad and strip foundations. The roof consists of plywood sheathing atop dimensional 2x12 roof joists, and the floors are constructed of plywood atop 2x8 floor joists. The lowest level consists of a conventional 4" thick cast-in-place concrete slab on grade. The roof and floor structure are supported by conventional wood framed stud walls around the exterior and built-up dimensional 2x beams supported by posts on the interior. These elements are founded on conventional cast-in-place concrete strip and pad foundations.

Based on our analysis, the existing lateral load resisting system does not have sufficient capacity and can only resist approximately 30% of Level 3 Seismic Force Levels (or 20% of NBC 2020 seismic force levels). The critical elements appear to be the wood frame exterior walls and diaphragm connections to these exterior walls. In addition, the foundations have not been sized to resist the compression or uplift requirements of exterior shear walls if they were upgraded.

- Diaphragm strengthening of the Roof and Level 2 diaphragms, which would consist of blocking and nailing the existing plywood panel edges. Flooring, ceiling finishes and roofing would need to be removed to perform this upgrade.
- The addition of sheathed wood frame interior shearwalls on both levels with hold-down anchor systems.
- The strengthening of exterior walls with additional plywood and new hold-down anchor systems.
- The addition of diaphragm connections to the new and strengthened shearwalls.
- The addition of new foundations under the new interior shearwalls
- Upgrading of the existing foundations under the exterior strengthened shearwalls. Upgrading likely involves locally removing the existing foundations and pouring new and larger foundations.

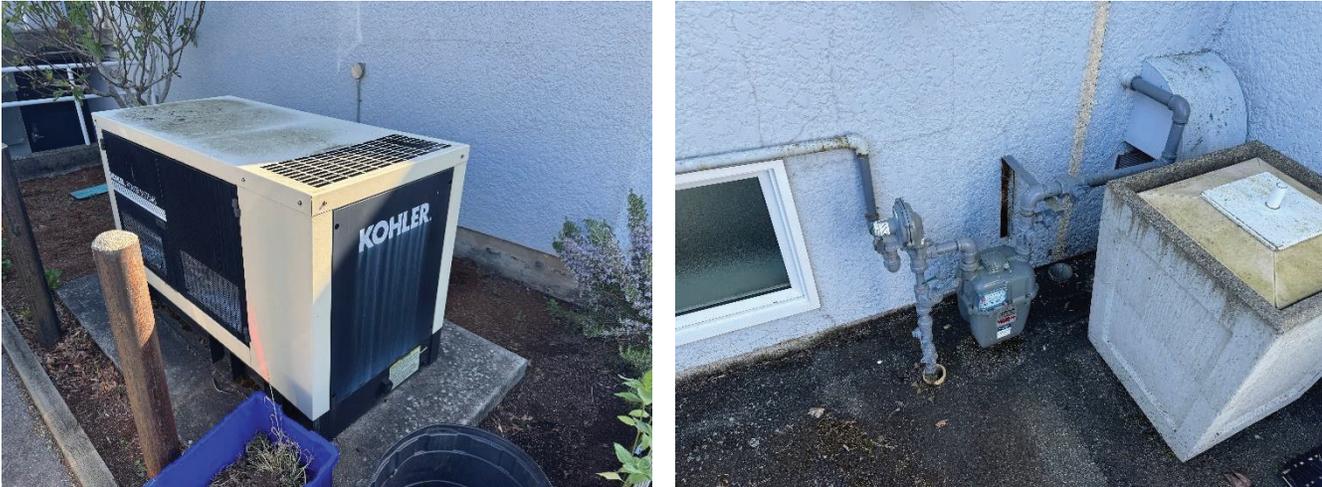
Figure 1. Natural gas generator (left) and natural gas meter adjacent to boiler room (right)

A natural gas meter is installed just north of the boiler room, outdoors, and accessible from the north parking lot. Natural gas is used primarily for building heating, and for the building's backup generator.

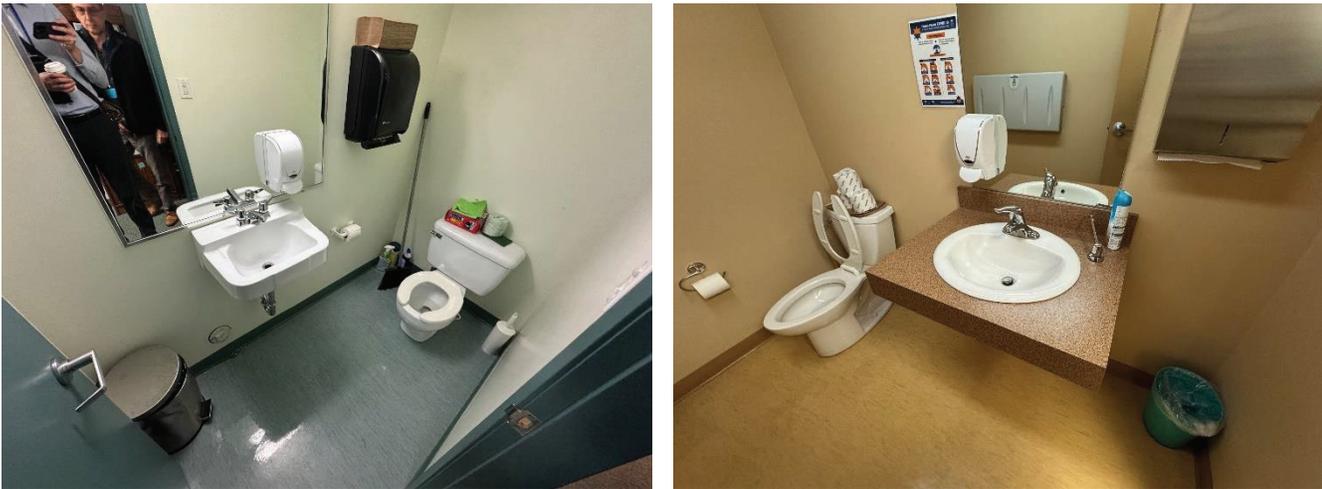
Figure 2. Typical washroom fixtures

Plumbing fixtures were standard vitreous china type, and were in moderate condition. Toilets and sink faucets were generally not low-flow type. Accessible washrooms were equipped with grab bars, but did not have bolt down toilet lids, sink basins that complied with accessibility standards, or insulation on plumbing traps or hot water supplies under sinks.

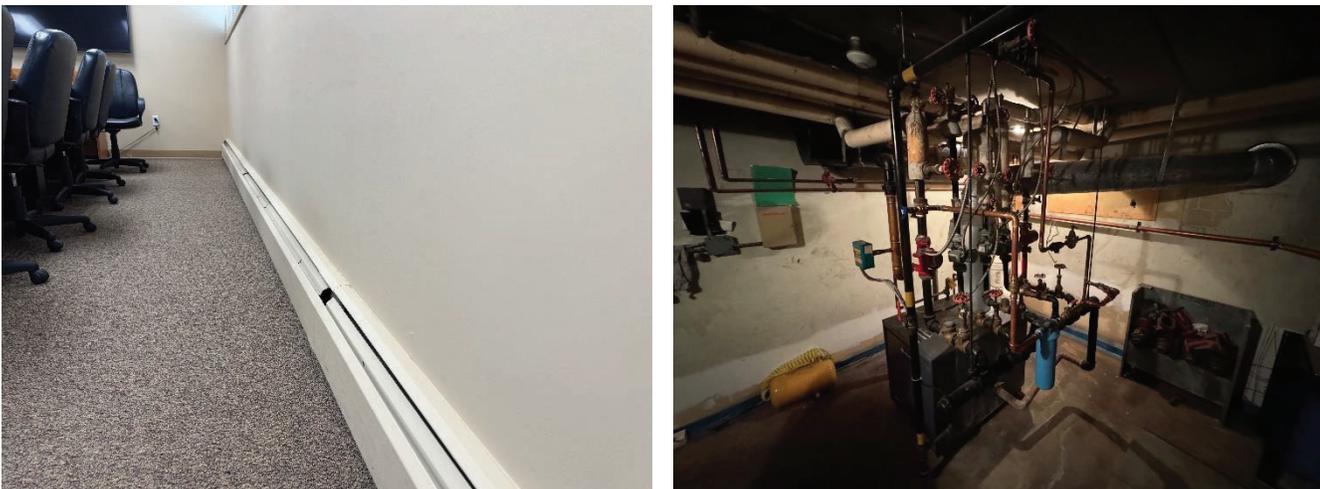
Figure 3. Hydronic radiator (left) and hydronic heating boiler with piping (right)

A natural gas hydronic heating boiler is located in the building's boiler room. The original mechanical drawings indicate that 5 zones were provided: two for the basement, and three for the main floor. Heating circulators are all located adjacent to the boiler. Piping within the boiler room was a combination of threaded steel and soldered copper piping. The boiler is an atmospherically vented Weil McLain.

Heating within the basement and main floor areas is through finned radiators and cabinet heaters. Reportedly, the system operates poorly. Hydronic heating service to various parts of the building is unreliable, or conflicts with other heating/cooling systems.

The hydronic heating system is in poor condition and requires replacement. However, we do not recommend replacing the hydronic system as is. Alternatives, such as additional heat pump systems, should be examined first, since they would also offer the opportunity to introduce mechanical ventilation and high efficiency heating/cooling instead of purely heating.

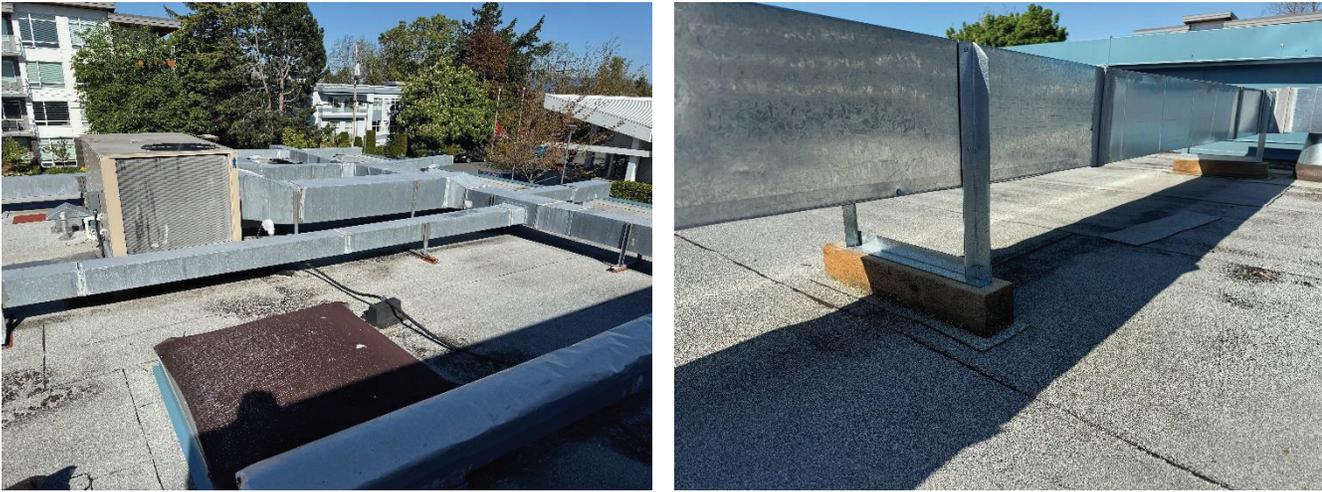
Figure 4. Rooftop ductwork and packaged rooftop heat pump (left) and rooftop ductwork supports (right)

Cooling and ventilation is provided by several packaged rooftop heat pumps. The heat pumps are equipped with economizers and barometric relief hoods. Air is distributed through lined ductwork on the roof, to ceiling diffusers within the various office spaces on the main floor. The packaged rooftop heat pumps were manufactured in 2019-2020, and have 10+ years of remaining useful service life.

The rooftop ductwork, which is supported on sleepers which are laying on top of the roof membrane, appears to be in good condition.

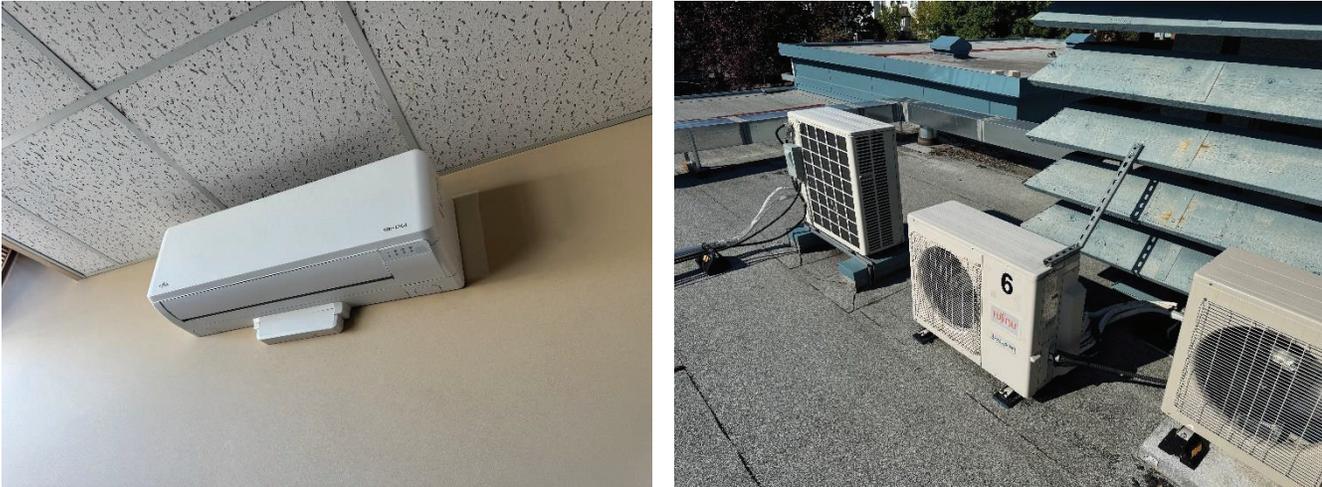
Figure 5. Ductless split system fan coil in office space (left) and ductless split outdoor heat pumps (right)

Cooling is also provided through ductless split system heat pumps, which serve the server room and the upper level office areas.
