**Data Gap Analysis Reay Creek Pond
Canora Road Between Northbrook Drive and Bowcott Place, Sidney, BC**

**May 2016
SLR Project No.: 201.02016.00001**

The Reay Creek Technical Working Group and the Town of Sidney required a review and interpretation of sediment investigation results collected since 2010, with a view to examine the need for, and feasibility of, future remediation and/or restoration of Reay Creek Pond.

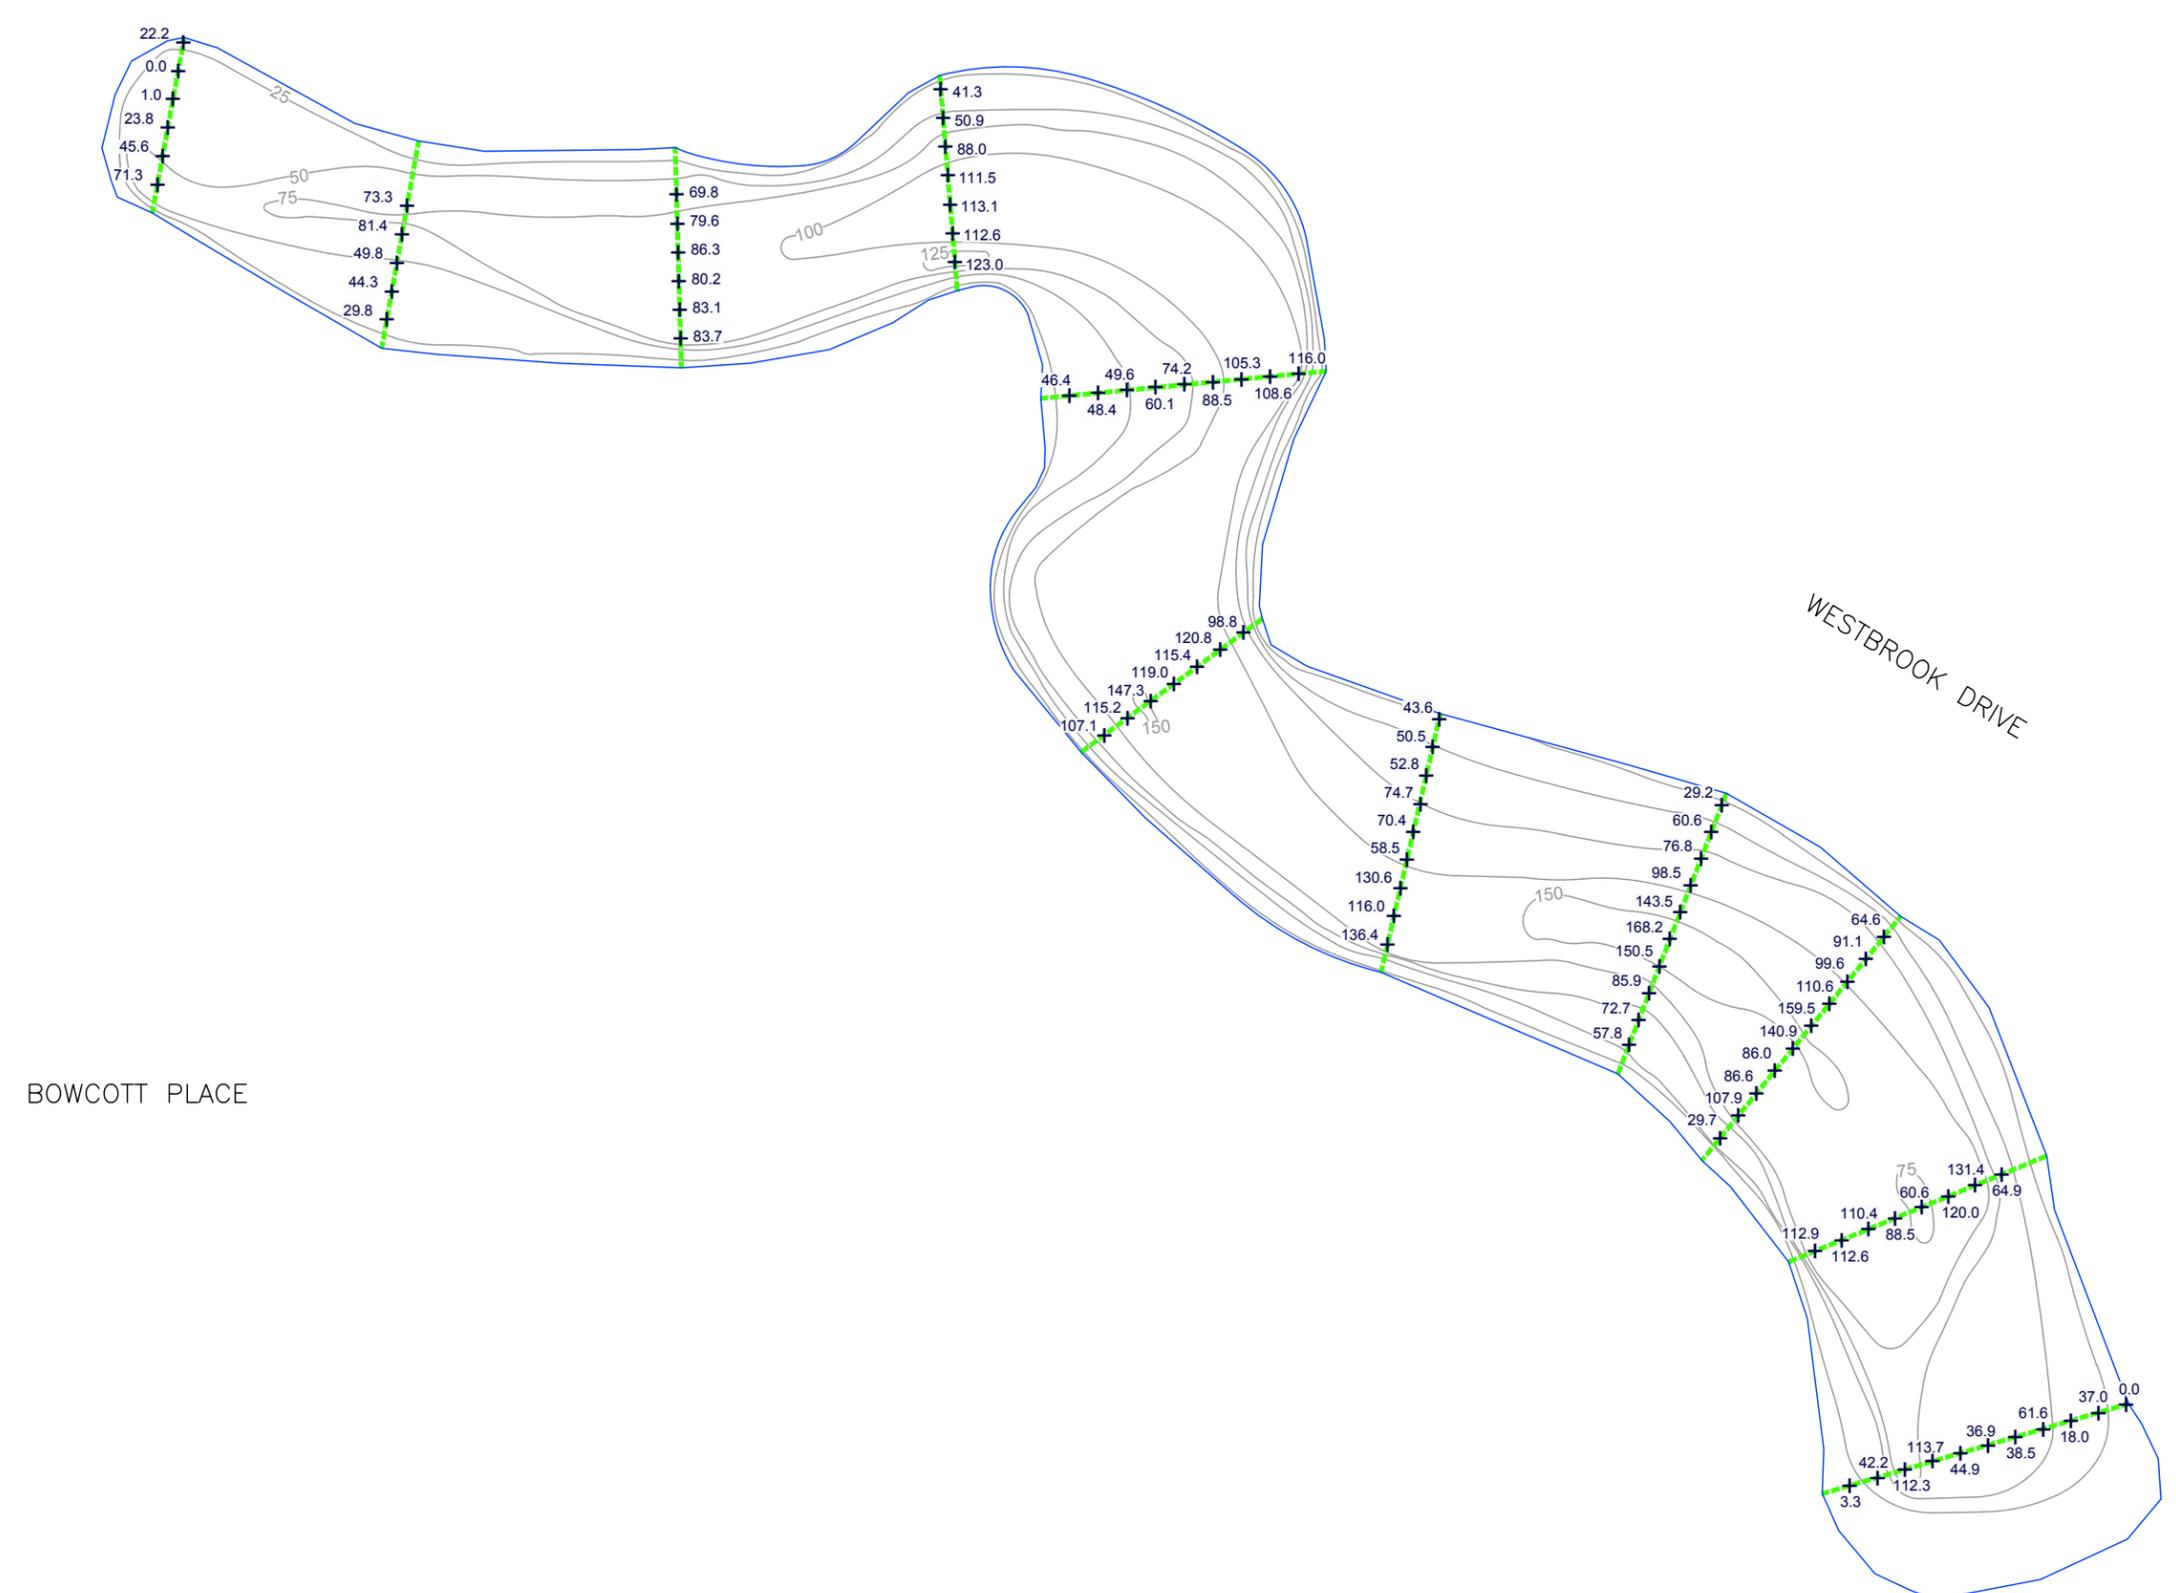
- APPROXIMATE LOCATION OF 2010 CAMOSUM COLLEGE STUDY TRANSECT (REAY CREEK POND REMEDIATION STUDY. ENVIRONMENTAL TECHNOLOGY PROGRAM. . MACDONALINSON & RACHELLE SARRAZIN. JUNE 2010)
- 25 CONTOUR (25cm INTERVAL)
- 83.7 SEDIMENT DEPTH (cm)

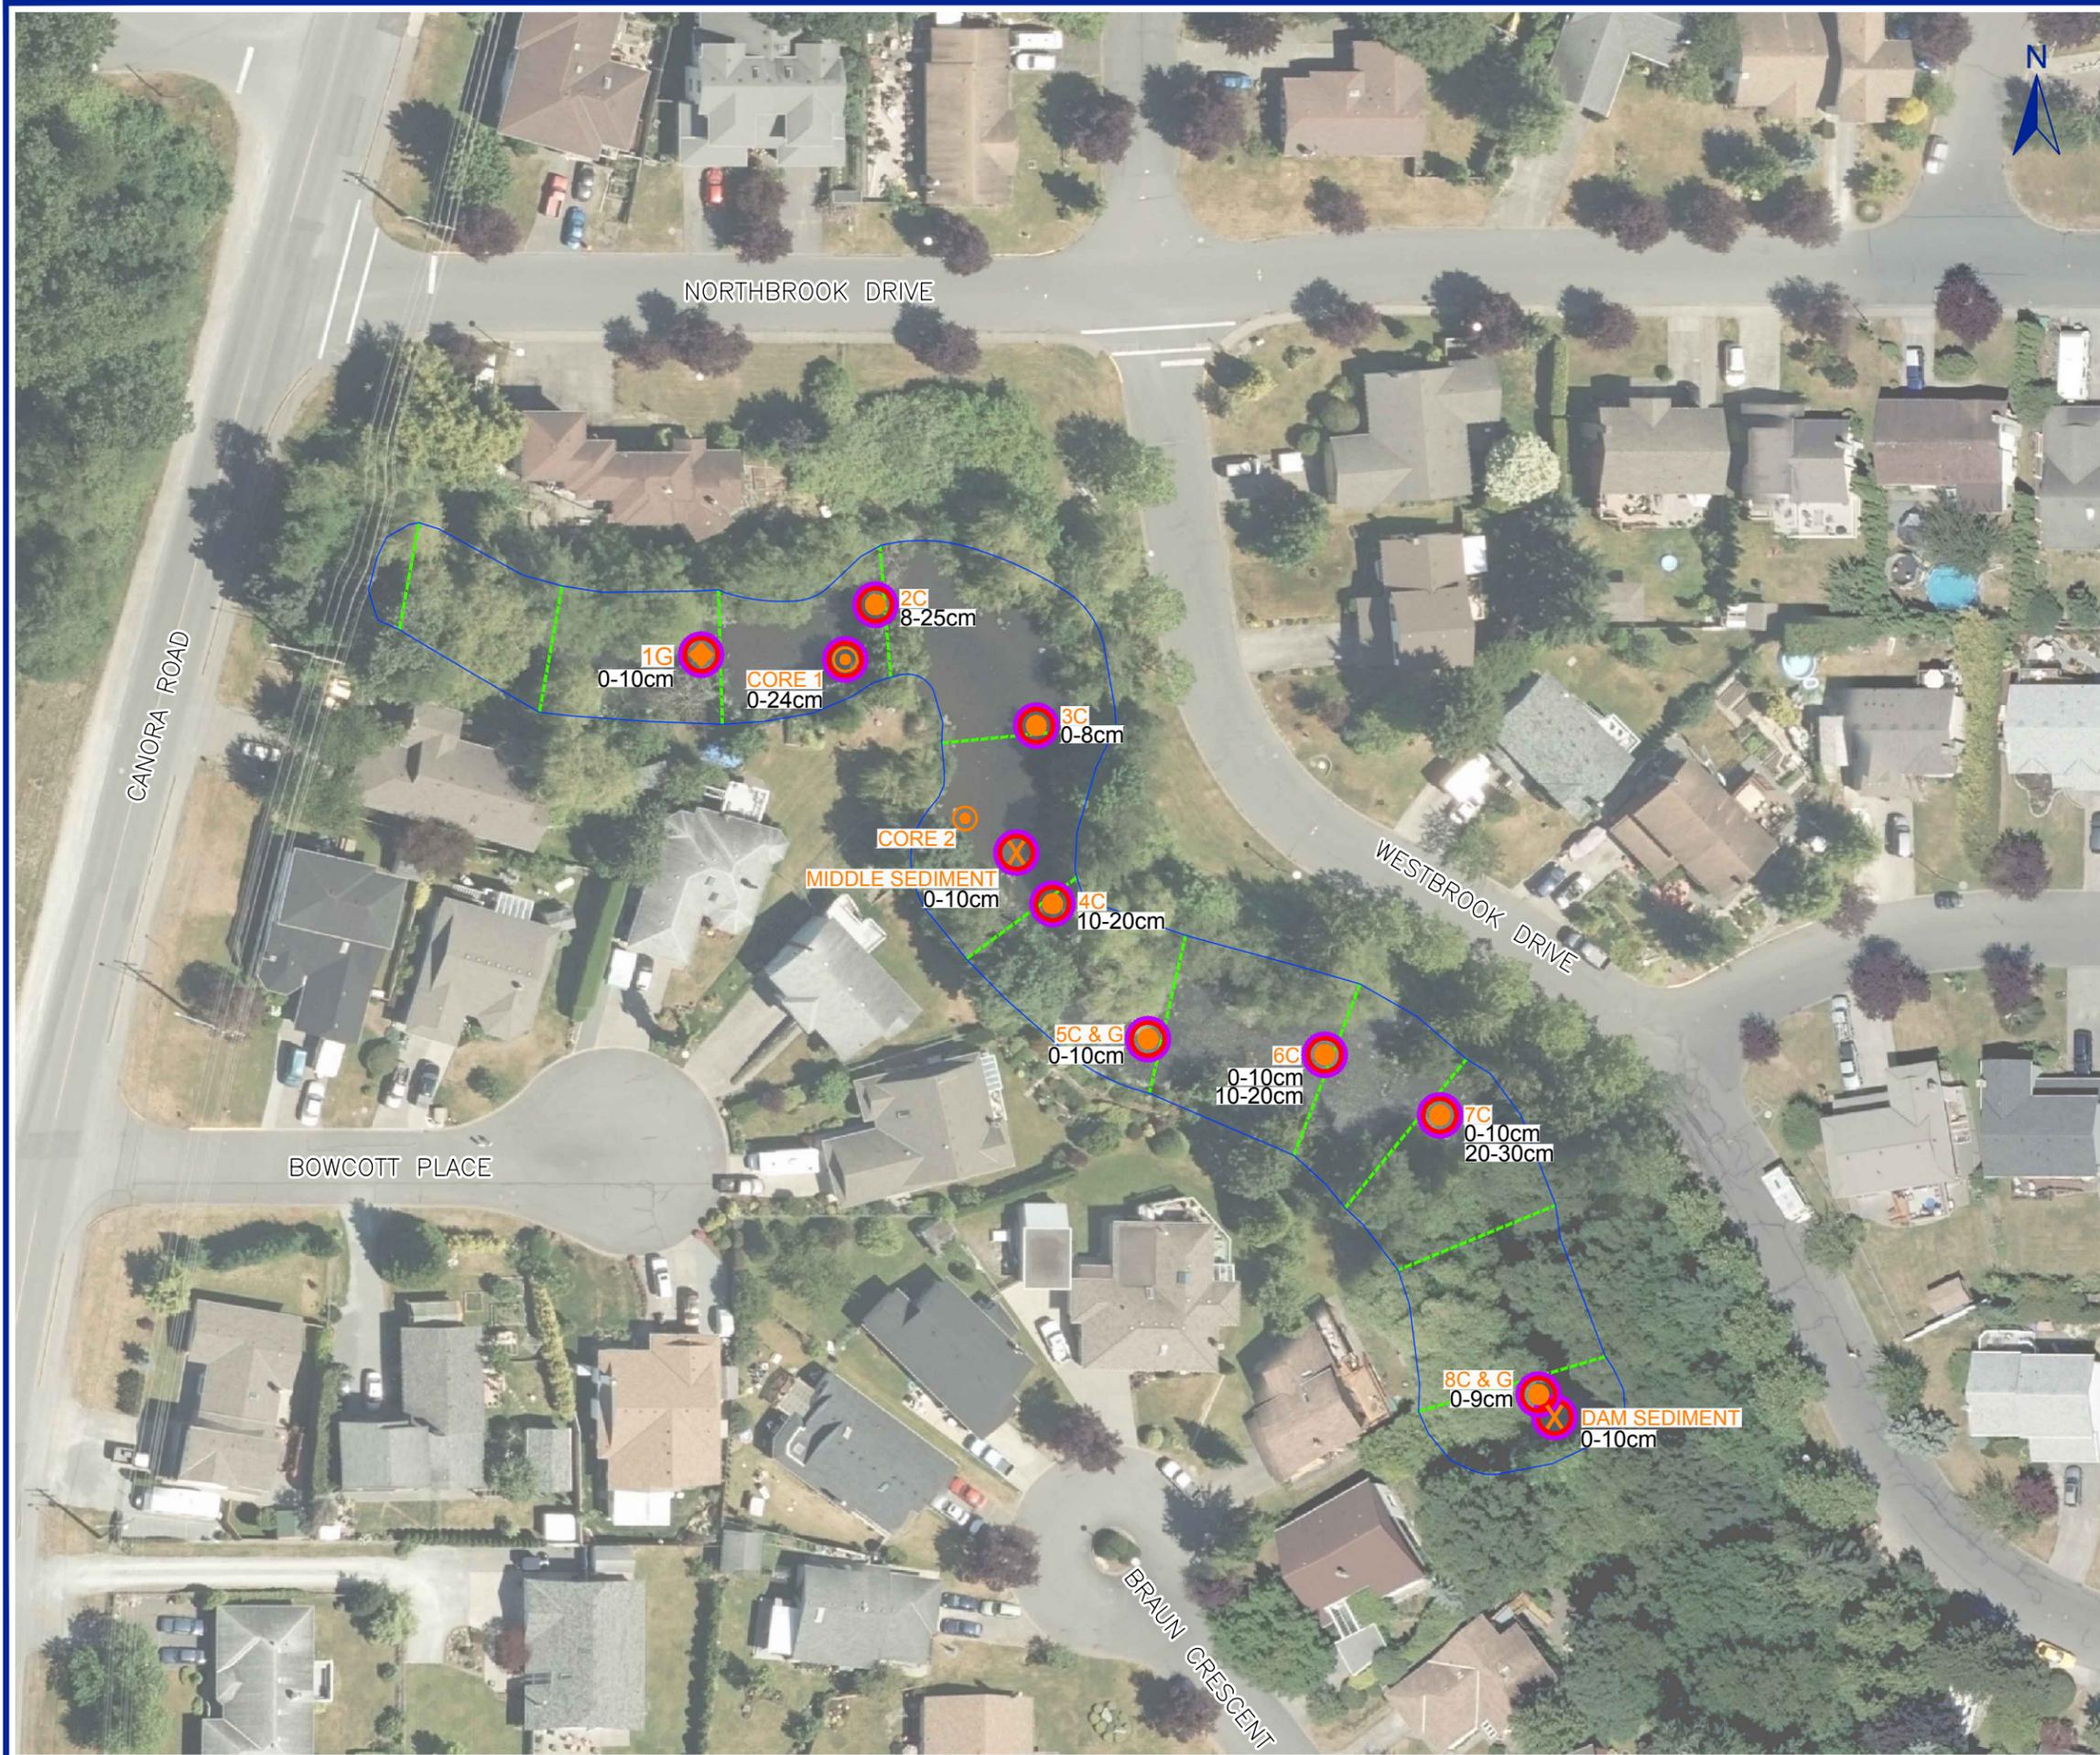
- NOTES:**
 REFERENCED FROM: CAPITAL REGIONAL DISTRICT, REGIONAL COMMUNITY ATLAS
- LEGAL DESCRIPTION:**
 SECTION 8, RANGE 3 EAST, NORTH SAANICH DISTRICT
 PID: 000-213-365
- LEGEND:**
- CORE SAMPLE LOCATION (2015, SLR)
 - CORE SAMPLE LOCATION (2013, MACDONALD & BRUCE)
 - ◆ GRAB SAMPLE LOCATION (2015, SLR)
 - X SEDIMENT SAMPLE LOCATION (2010, ROBINSON AND SARRAZIN)
 - - - APPROXIMATE LOCATION OF 2010 CAMOSUM COLLEGE STUDY TRANSECT (REAY CREEK POND REMEDIATION STUDY. ENVIRONMENTAL TECHNOLOGY PROGRAM. JUSTIN ROBINSON & RACHELLE SARRAZIN. JUNE 2010)
 - **SEDIMENT LABORATORY ANALYSIS RESULTS**
CONCENTRATION(S) GREATER THAN APPLICABLE SDFs STANDARD(S)
 - CONCENTRATION(S) GREATER THAN APPLICABLE SDFs STANDARD(S)
 - 0-10cm DEPTH OF SAMPLE COLLECTED (cm)

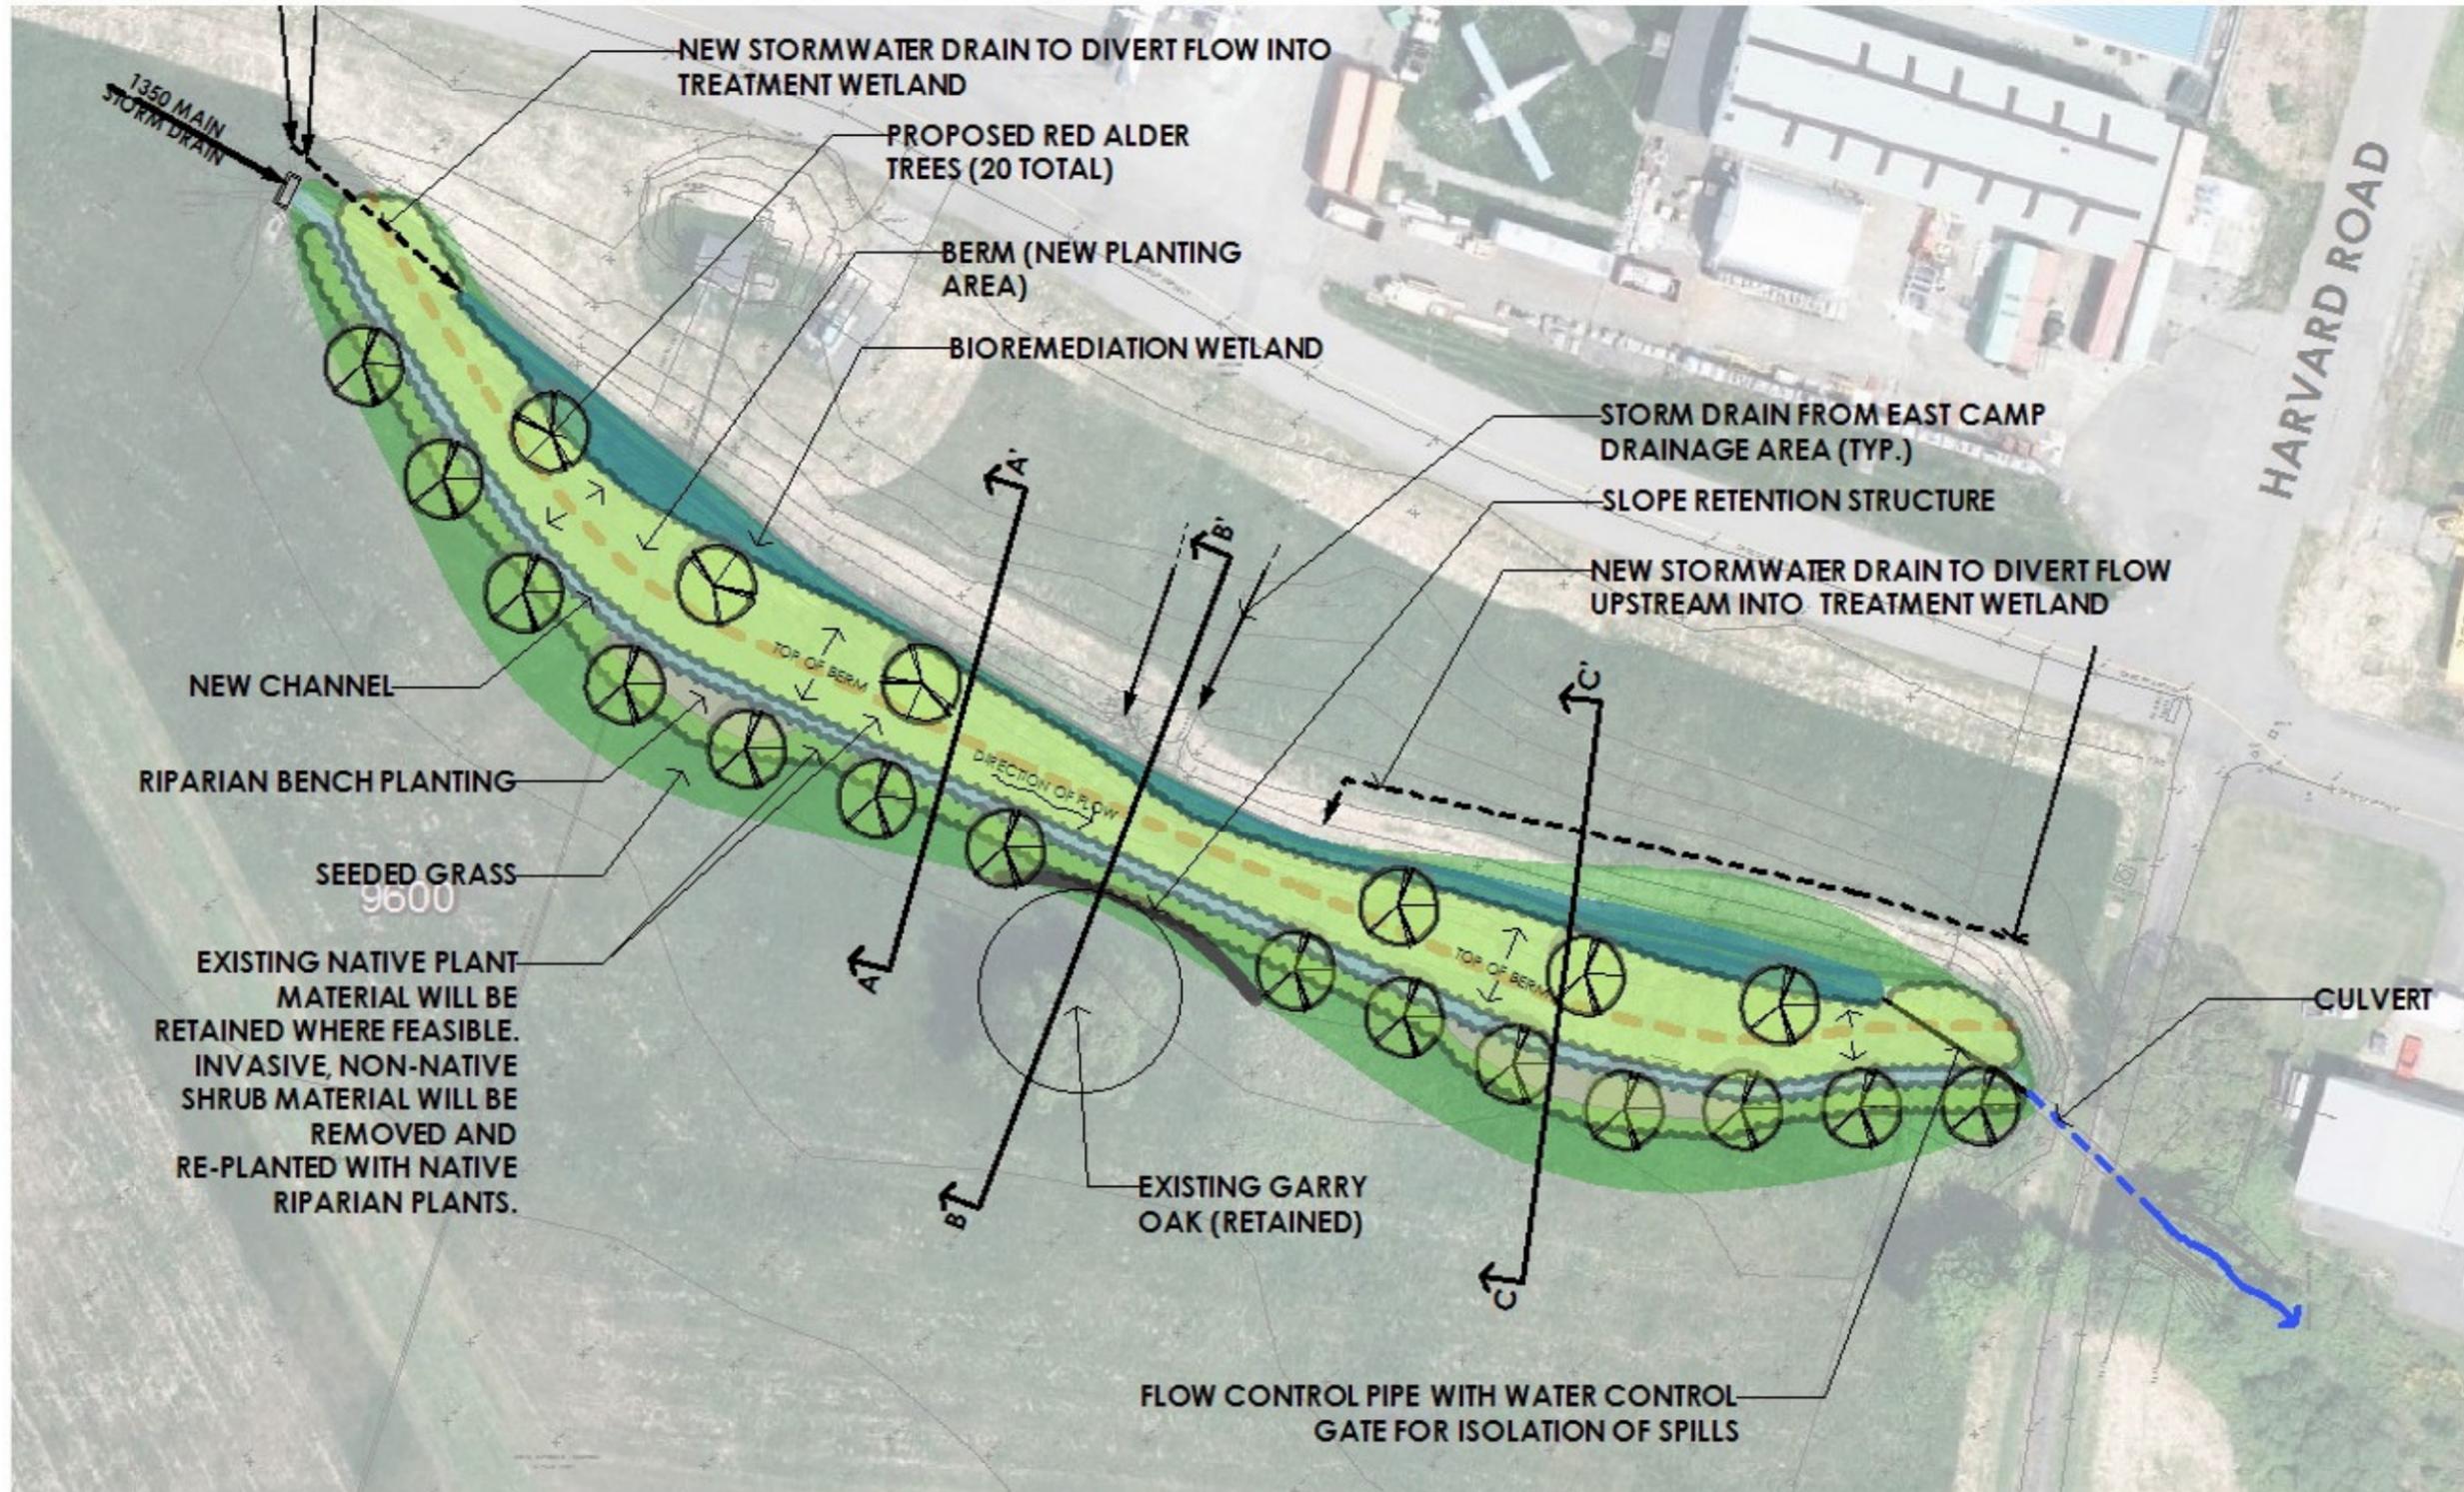
CONCEPT PLAN
REAY CREEK REHABILITATION

The new channel will be designed to control flow velocities through addition of floodplain benches and riffle structures. The new channel will also provide stormwater management capacity and will include erosion control measures such as biodegradable erosion control matting and riparian plantings to provide bank stability and riparian cover.

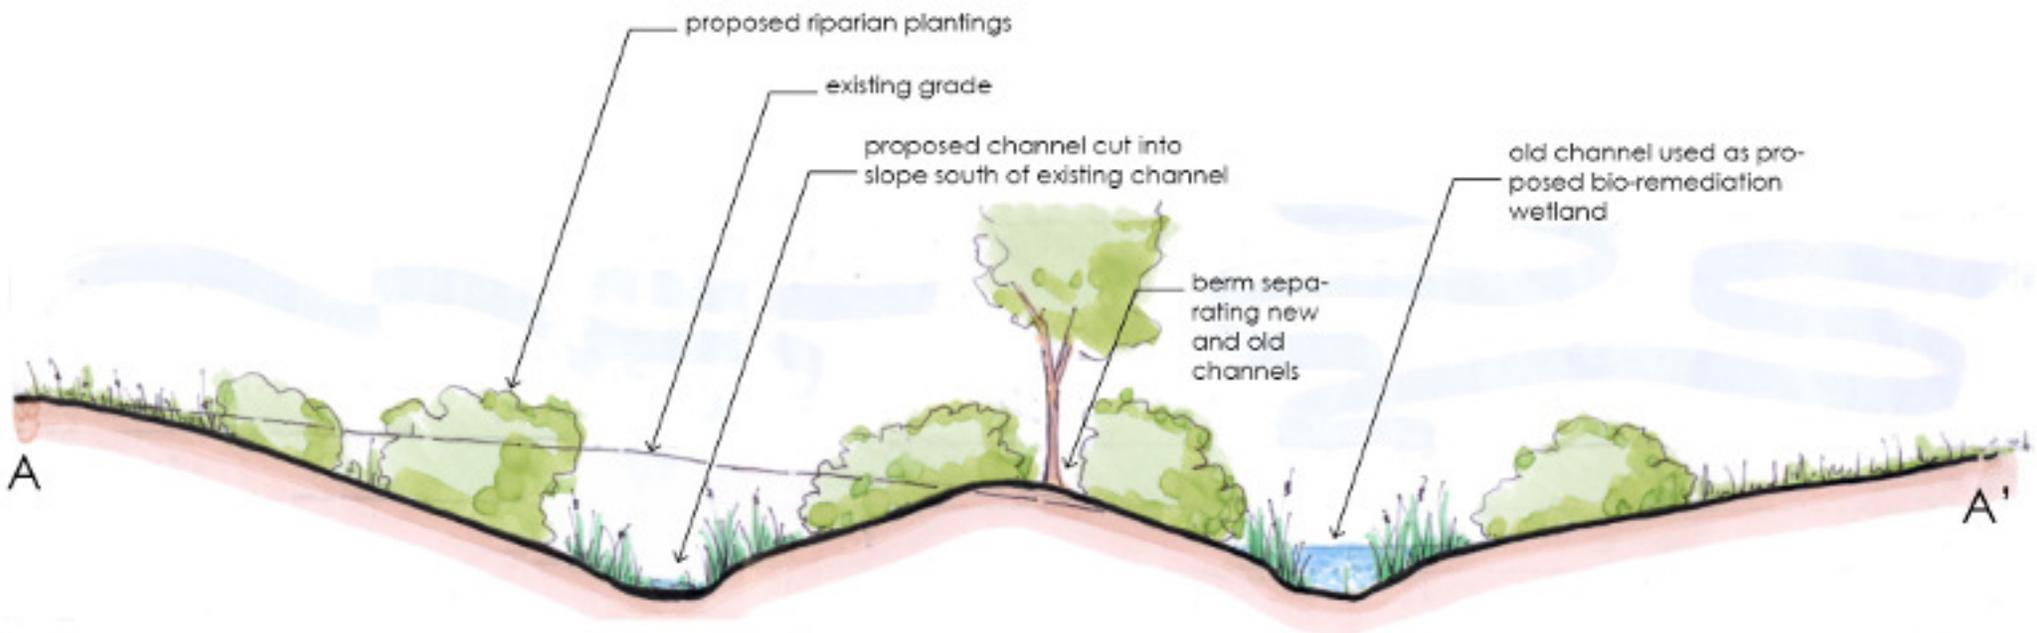
Section A-A' - Typical Channel Cut

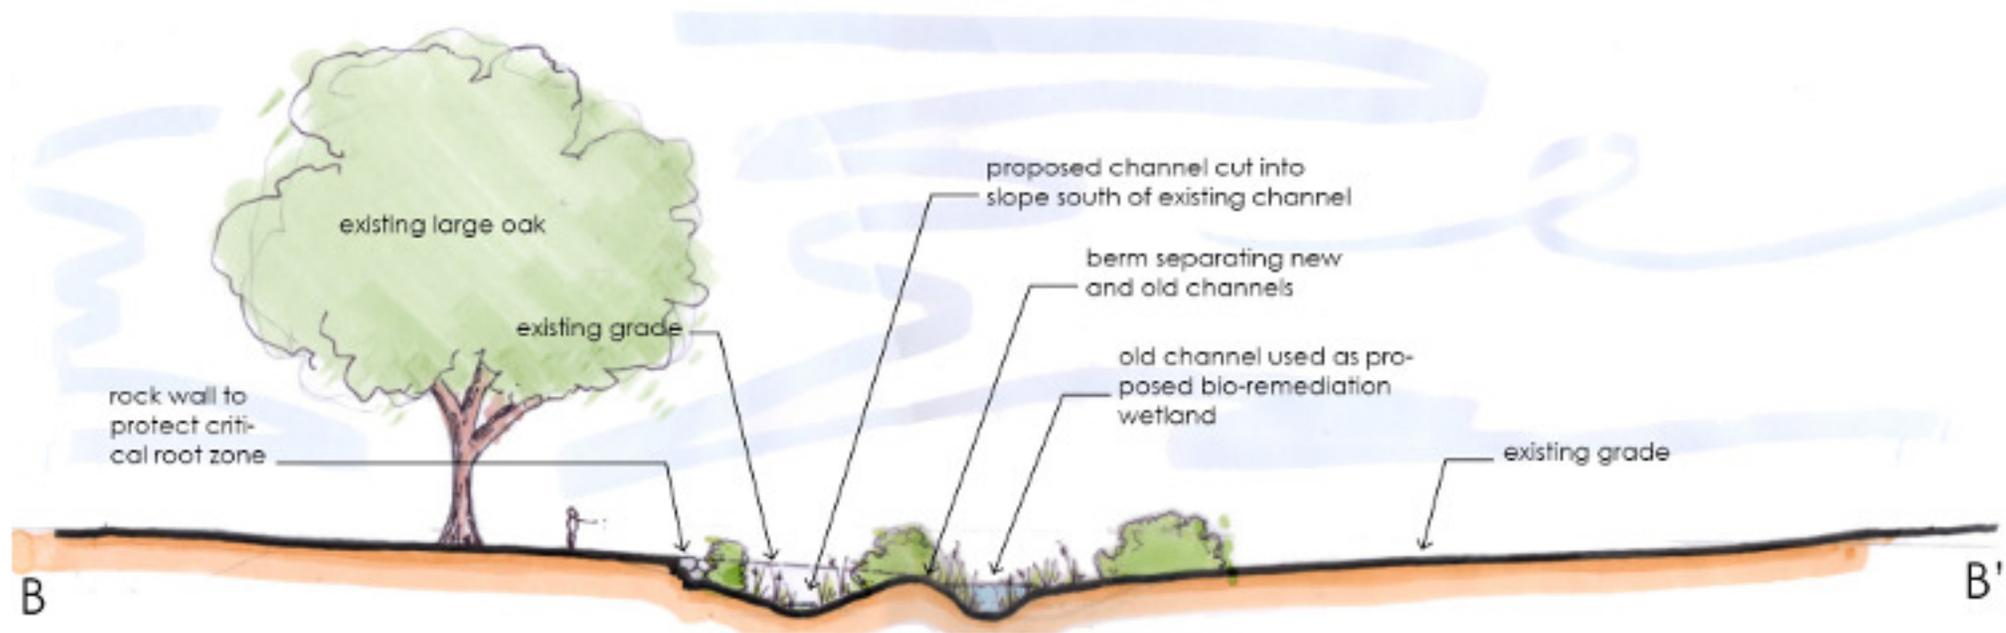
Section B-B' - Context Section (w/ Large Oak)

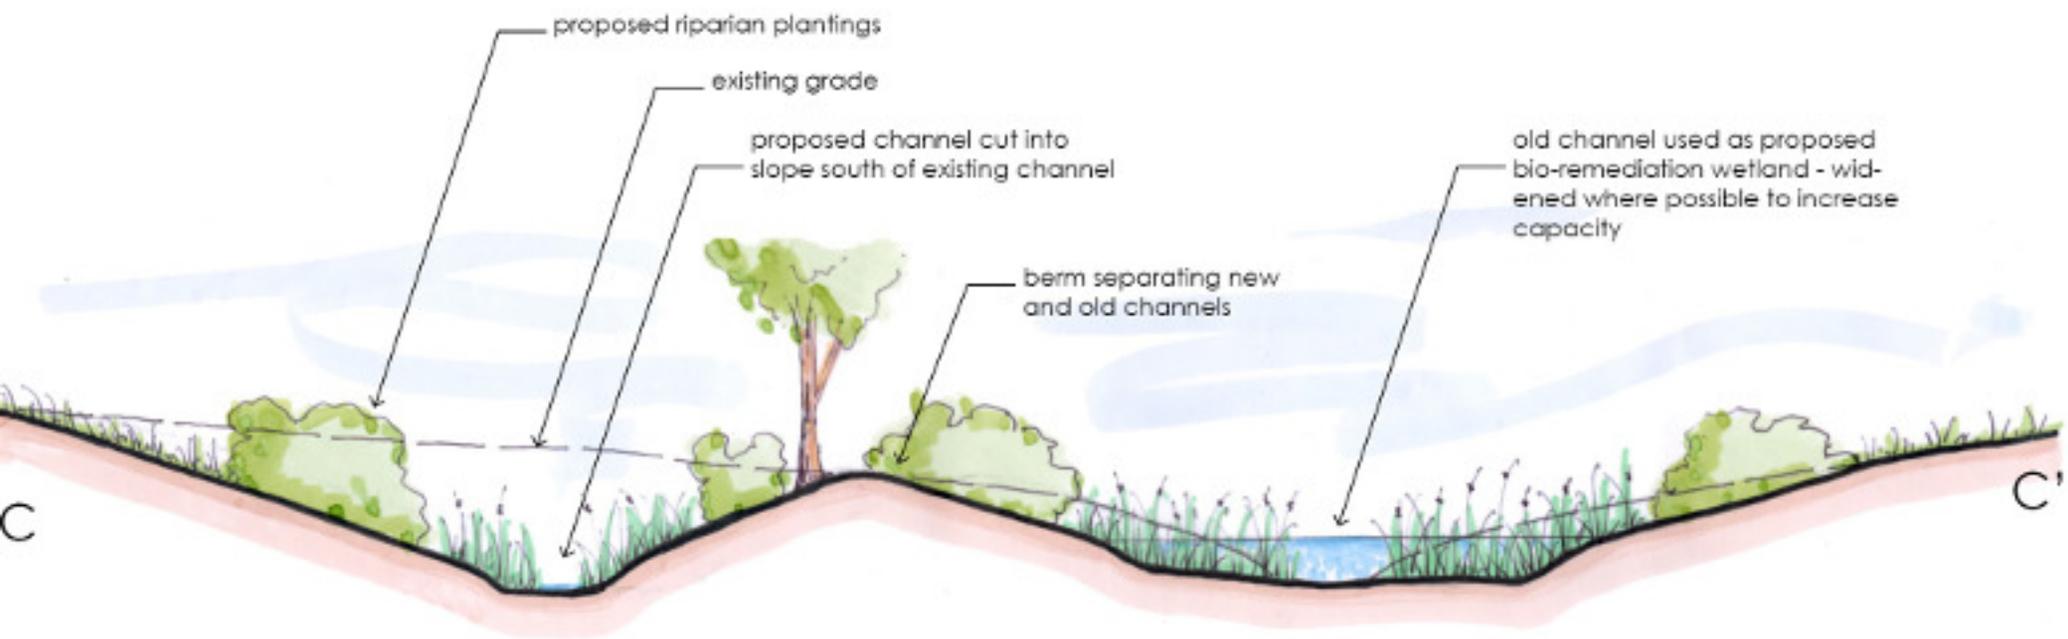
Section C-C' - Widened Bio-remediation Wetland

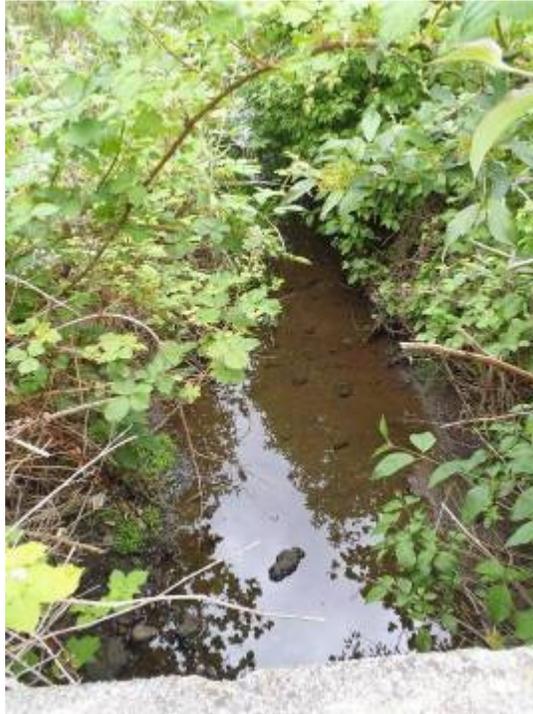
Photograph 1: Existing Reay Creek channel immediately downstream of stormwater outfall at the eastern-most (upstream) end of the creek (June 13, 2012).

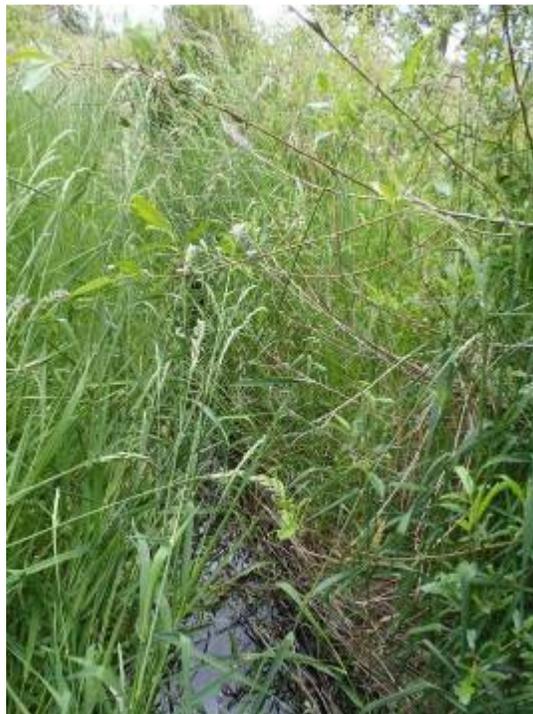
Photograph 2: Minimal flow further downstream of stormwater outfall with grassy riparian vegetation (June 13, 2012).

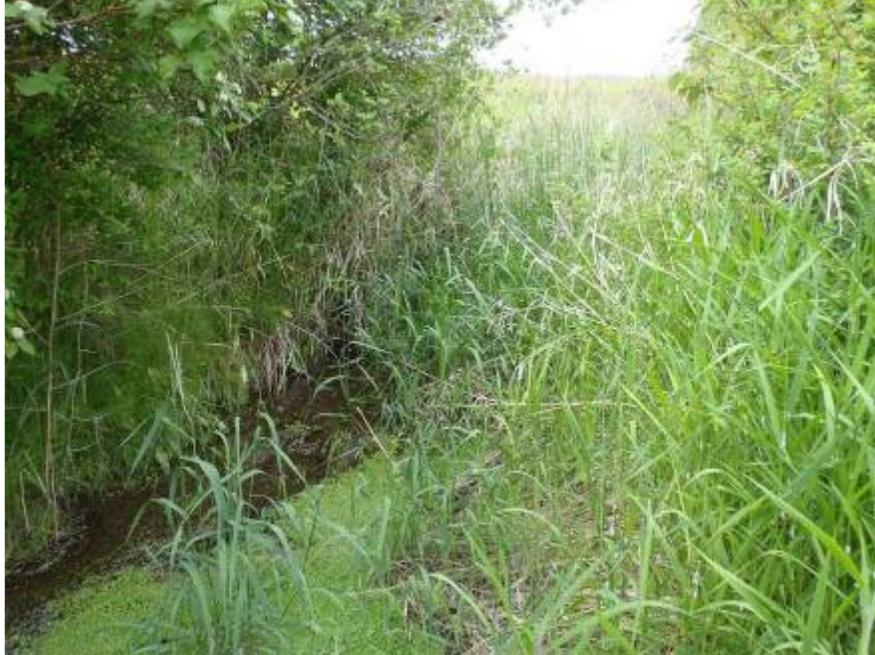
Photograph 3: Sparse shrub and grassy riparian vegetation along mid-section of proposed project area (June 13, 2012).

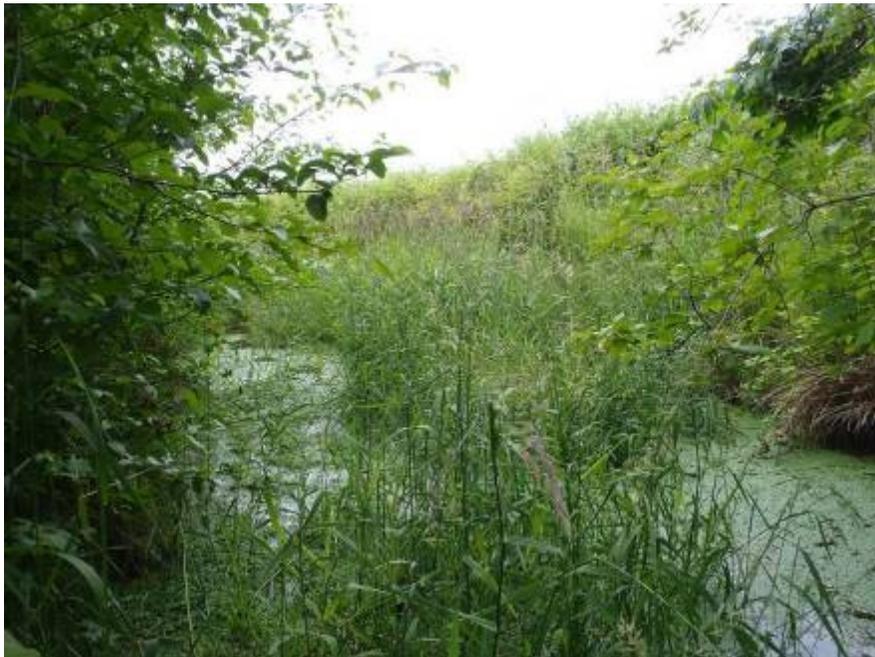
Photograph 4: Riparian vegetation slightly more pronounced at downstream end of project area. Thick mats of in-stream vegetation present due to stagnant flow (June 13, 2012).

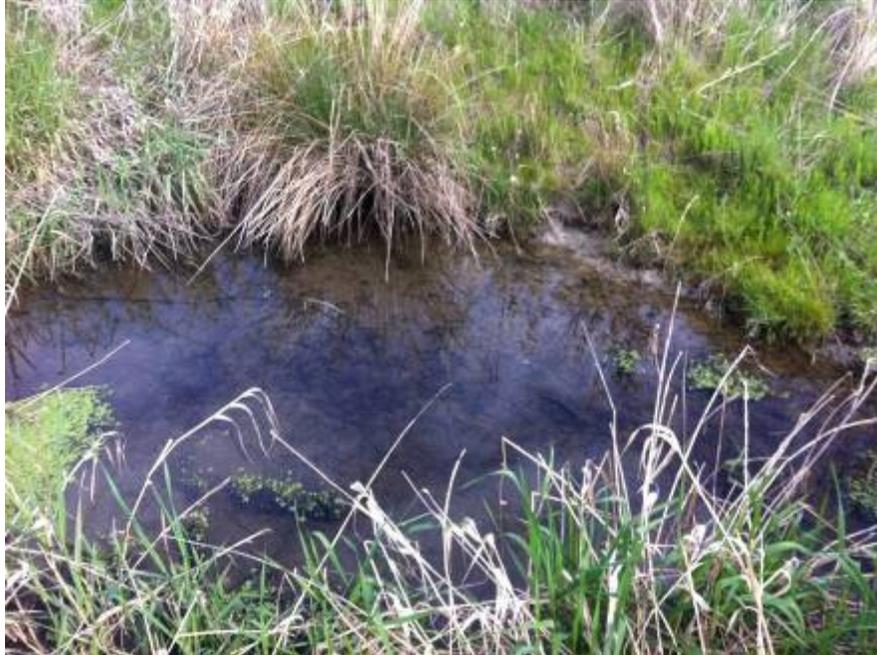
Photograph 5: Typical substrates consisting of fine-grained silty sediments and organic debris (June 13, 2012).

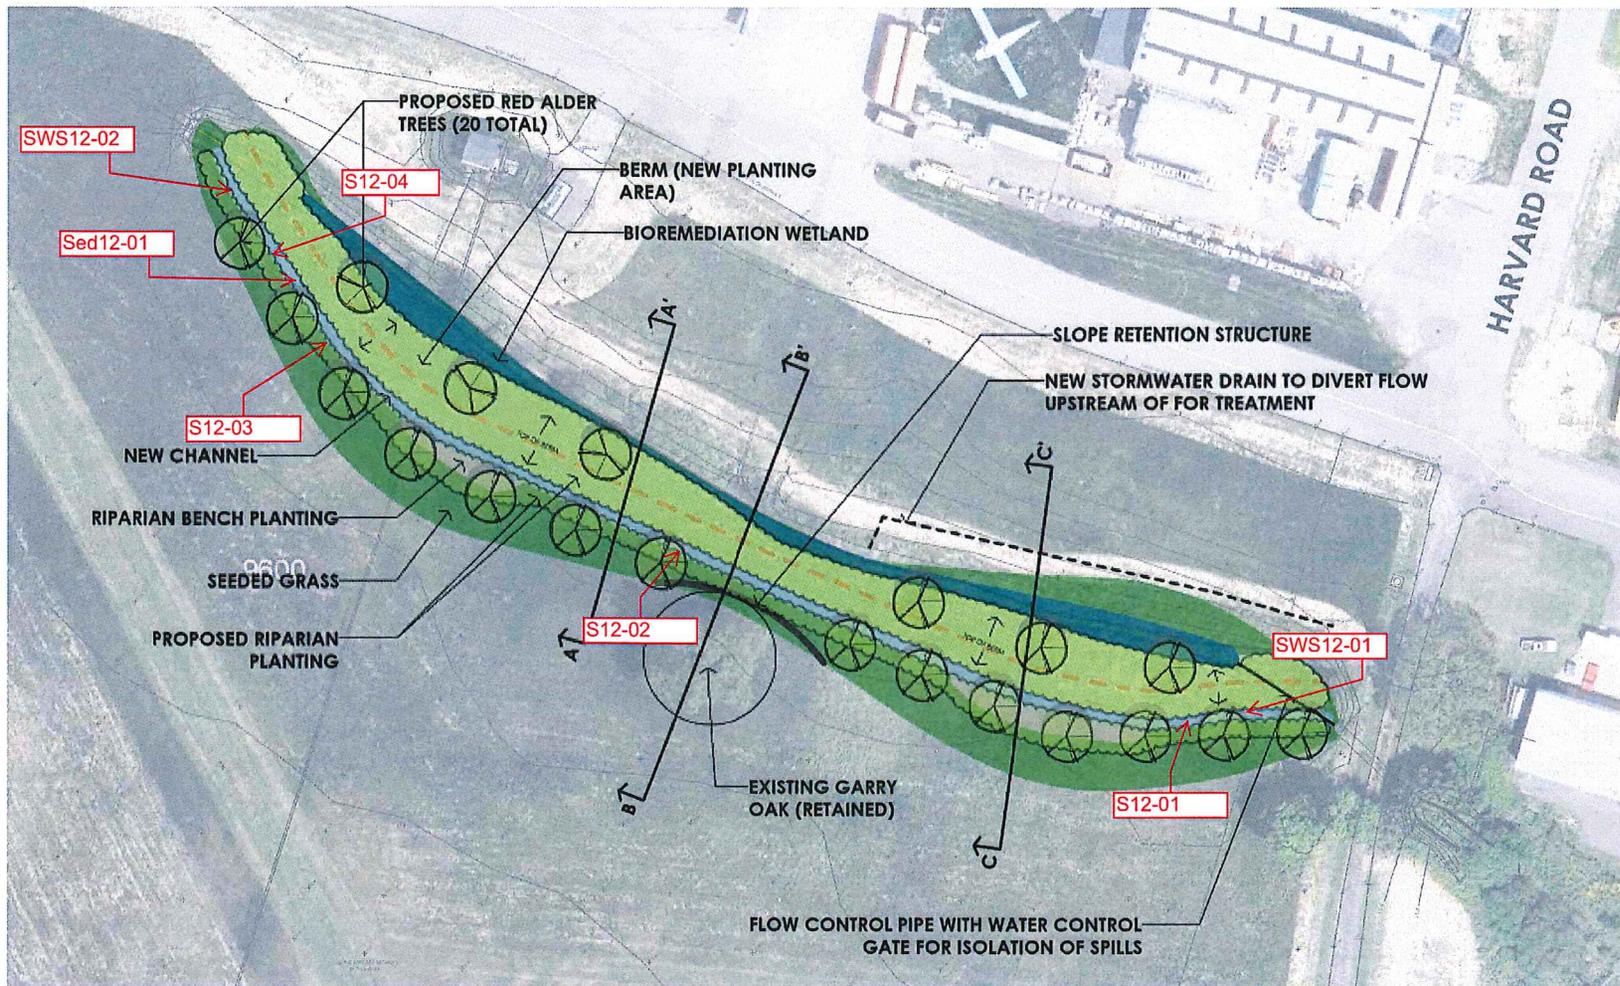
Drawing 1: Sediment and Water Sampling Locations

SLR collected sediment samples from the water – creek bank interface at four locations within the newly constructed Reay Creek channel (sampling stations 3609 S12-01 to S12-04). At each sediment sampling location samples were collected from surface sediment layers (0 – 10 cm depth) using cleaned stainless steel spoons and bowls from immediately below, at, and above the existing water line along the margins of the creek. All samples were collected from below the high water line. Sediments were placed in a clean stainless steel bowl and mixed prior to being placed in laboratory prepared 125 mL glass jars, which were labelled and stored in an insulated, ice-chilled cooler until they were shipped to ALS Environmental Laboratories (ALS) for analysis. Sampling equipment was washed with Alconox detergent between sampling stations to avoid cross contamination. One blind field duplicate was collected for quality assurance/quality control purposes.

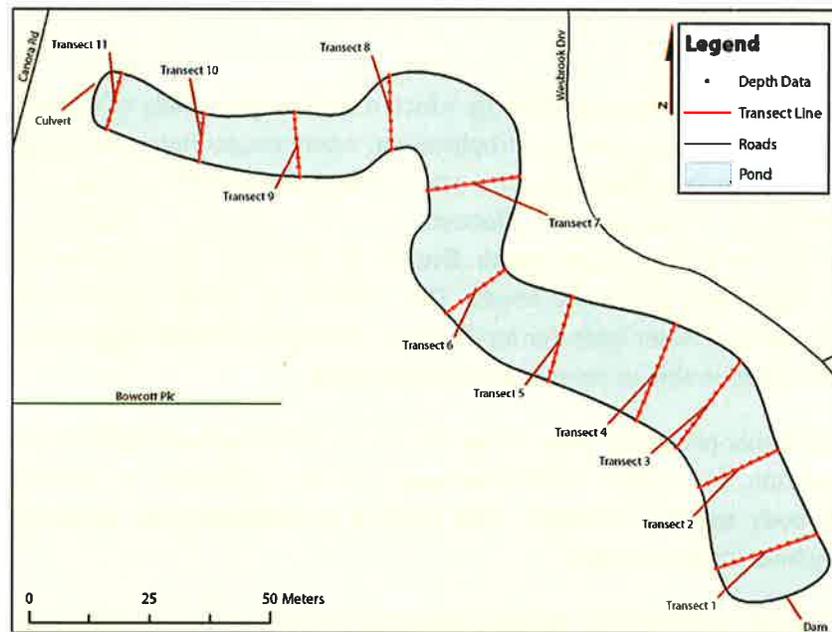
Figure 2 – Map showing transect locations and data collection points for Reay Creek Pond study, June 2010

Reay Creek Pond was divided into 11 transects every 20 meters. The first transect started 5 m away from the dam, as poor sediment levels were found close to the dam. The location of the second transect was determined by measuring 20 m away from the first transect on both shores. Transects 3 and 4 were measured 10 meters away from the last transect on one shore and 20 m away on the opposing shore in order to compensate for a sharp turn. After Transect 4, each transect was measured by connecting a 50 m measuring tape to the center of the previous transect and measuring 20 m while following the contours of the pond. The location of the next transect was visually defined by features on both shores and the addition of red flagging tape. Transect locations can be seen in Figure 2.

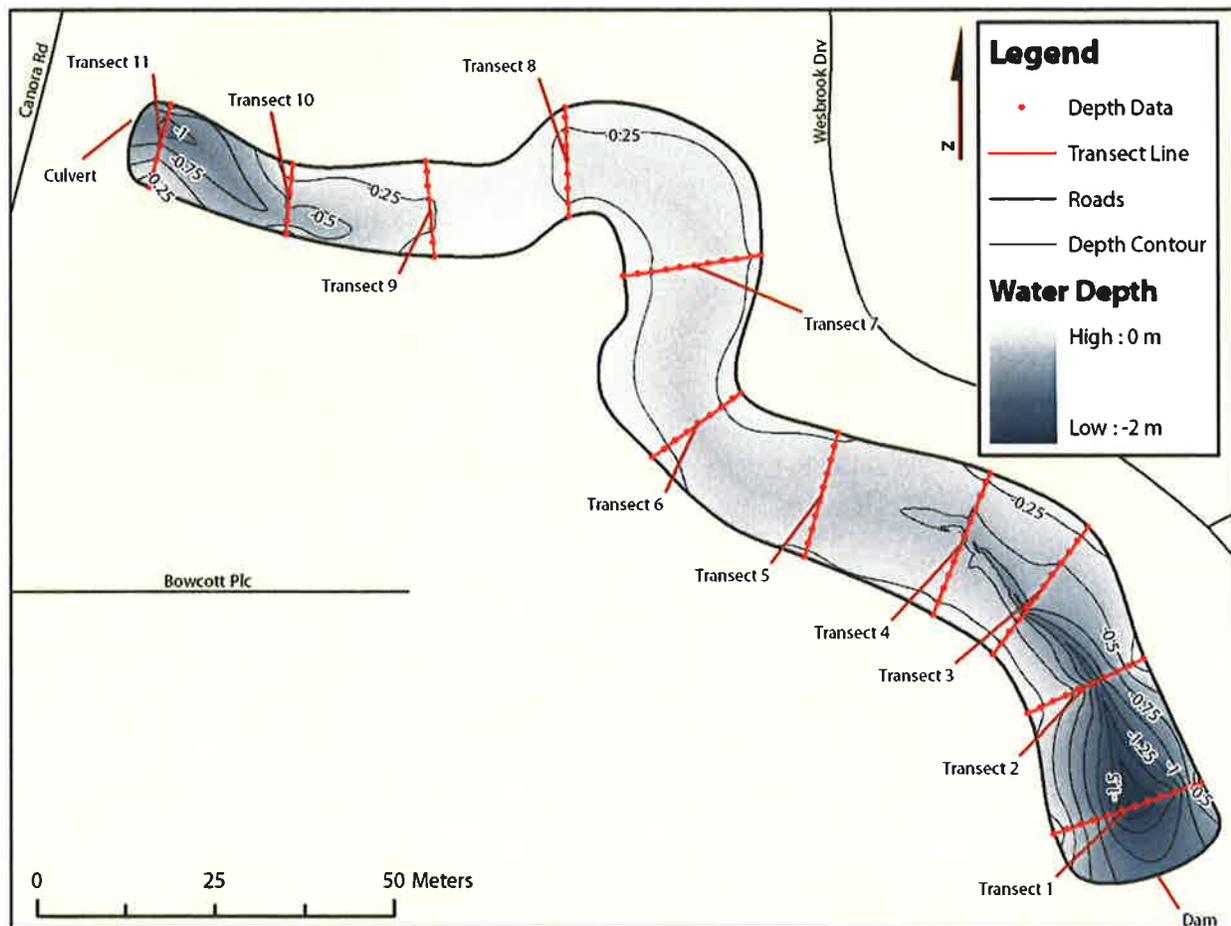
Figure 3 – Water Depth Contour Map of Reay Creek Pond, June 2010

Two maps were produced using the collected depth data (Table 1 of Appendix A). Figure 3 shows the depth of water and Figure 4 shows the depth of sediment in Reay Creek Pond. A third map (Figure 5) was produced to show the thickness of sediment.

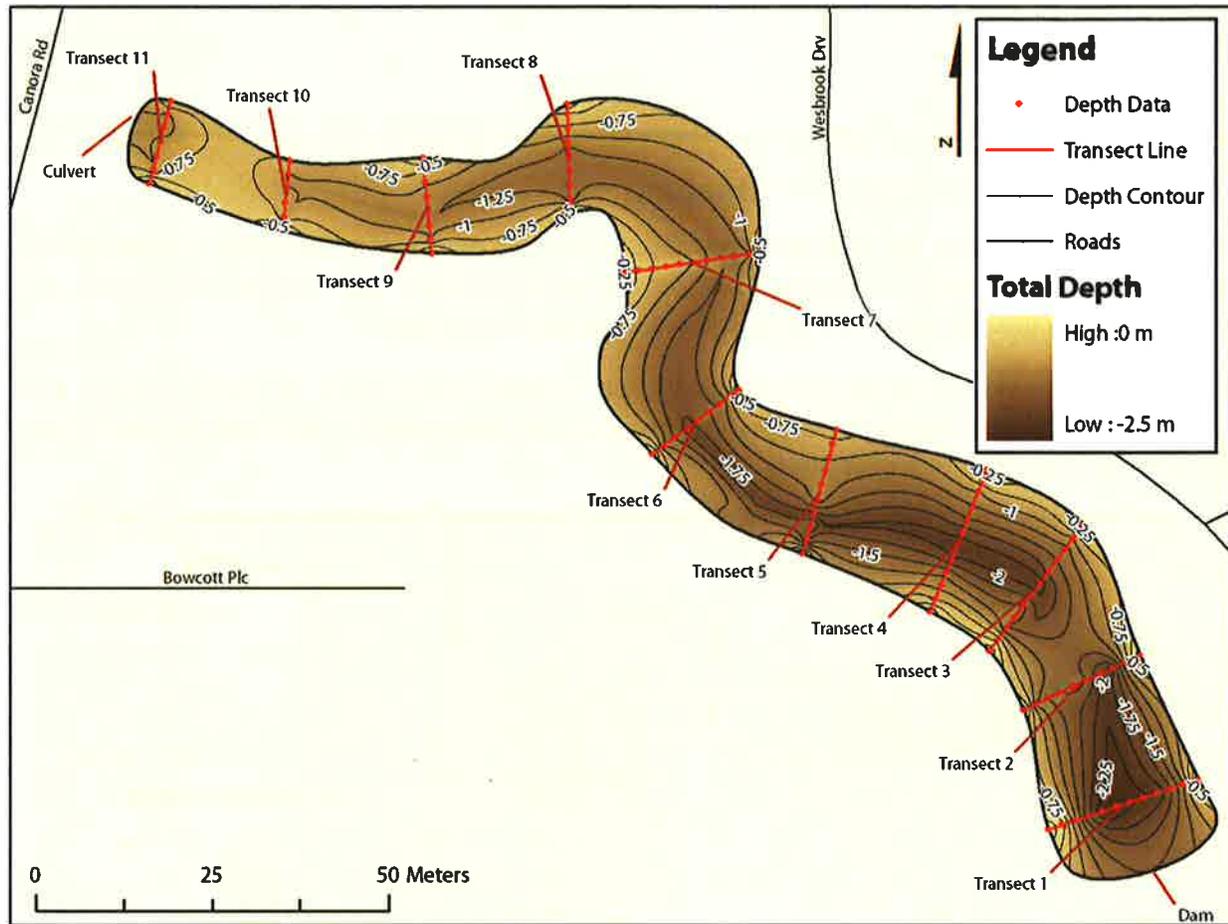
Figure 4 – Total Depth Contour Map of Reay Creek Pond, June 2010
