**Data Gap Analysis Reay Creek Pond
Canora Road Between Northbrook Drive and Bowcott Place, Sidney, BC**

**May 2016
SLR Project No.: 201.02016.00001**

The Reay Creek Technical Working Group and the Town of Sidney required a review and interpretation of sediment investigation results collected since 2010, with a view to examine the need for, and feasibility of, future remediation and/or restoration of Reay Creek Pond.

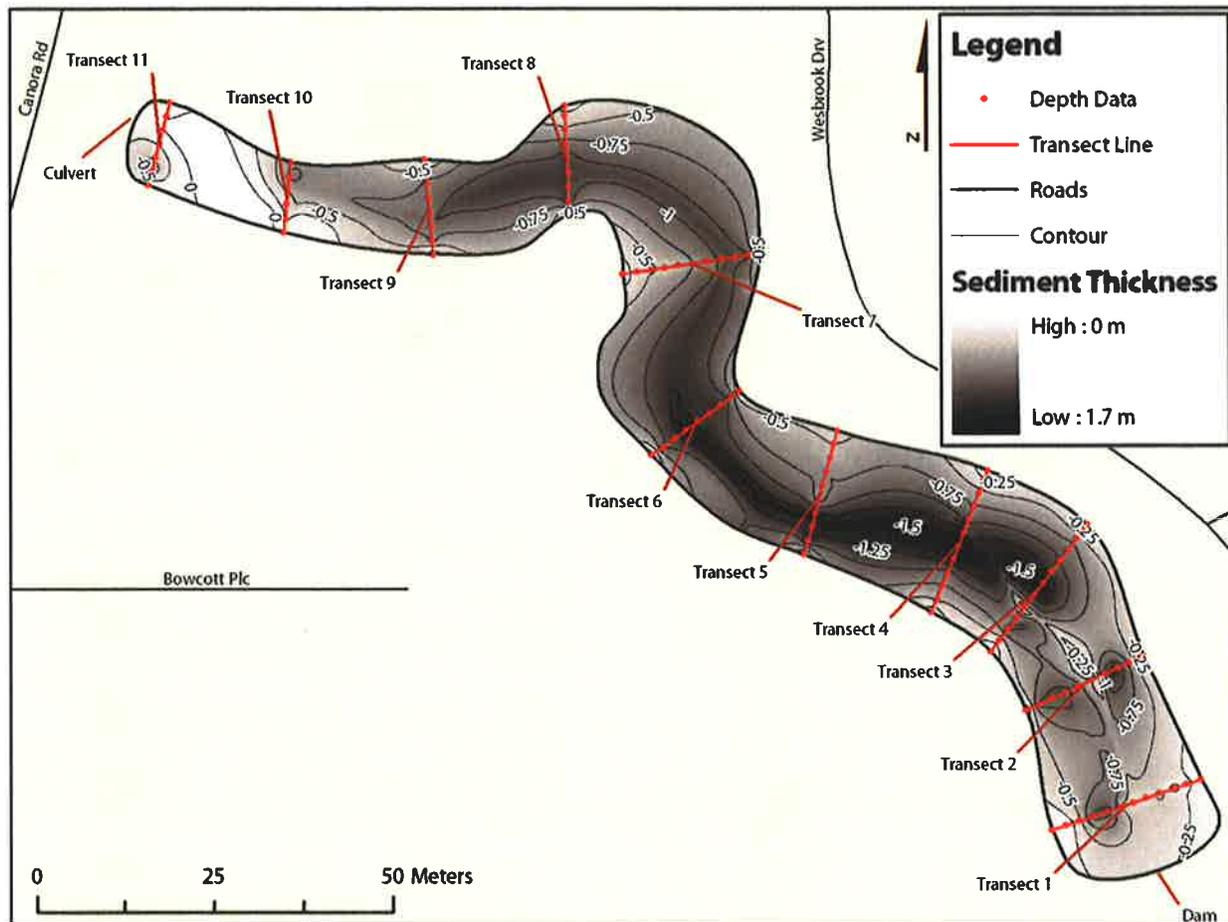
Figure 5 – Thickness of Sediment and Contours Map of Reay Creek Pond, June 2010

Two maps were produced using the collected depth data (Table 1 of Appendix A). Figure 3 shows the depth of water and Figure 4 shows the depth of sediment in Reay Creek Pond. A third map (Figure 5) was produced to show the thickness of sediment.

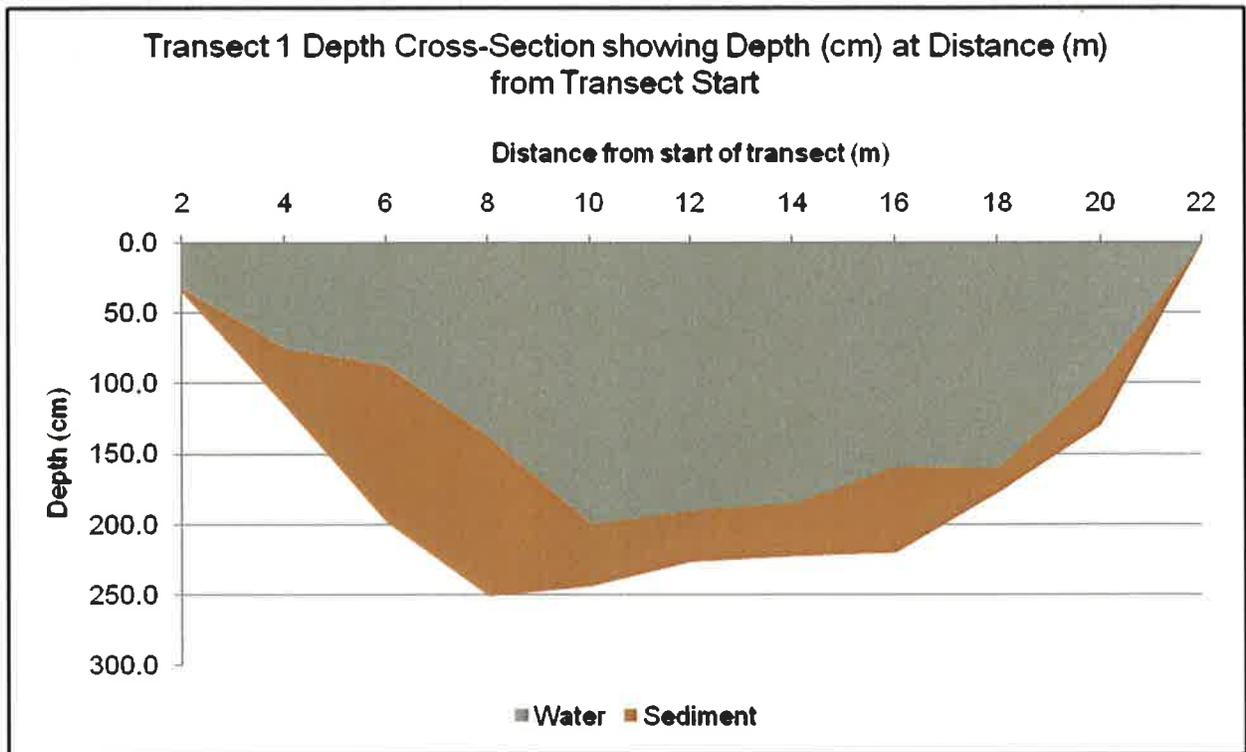
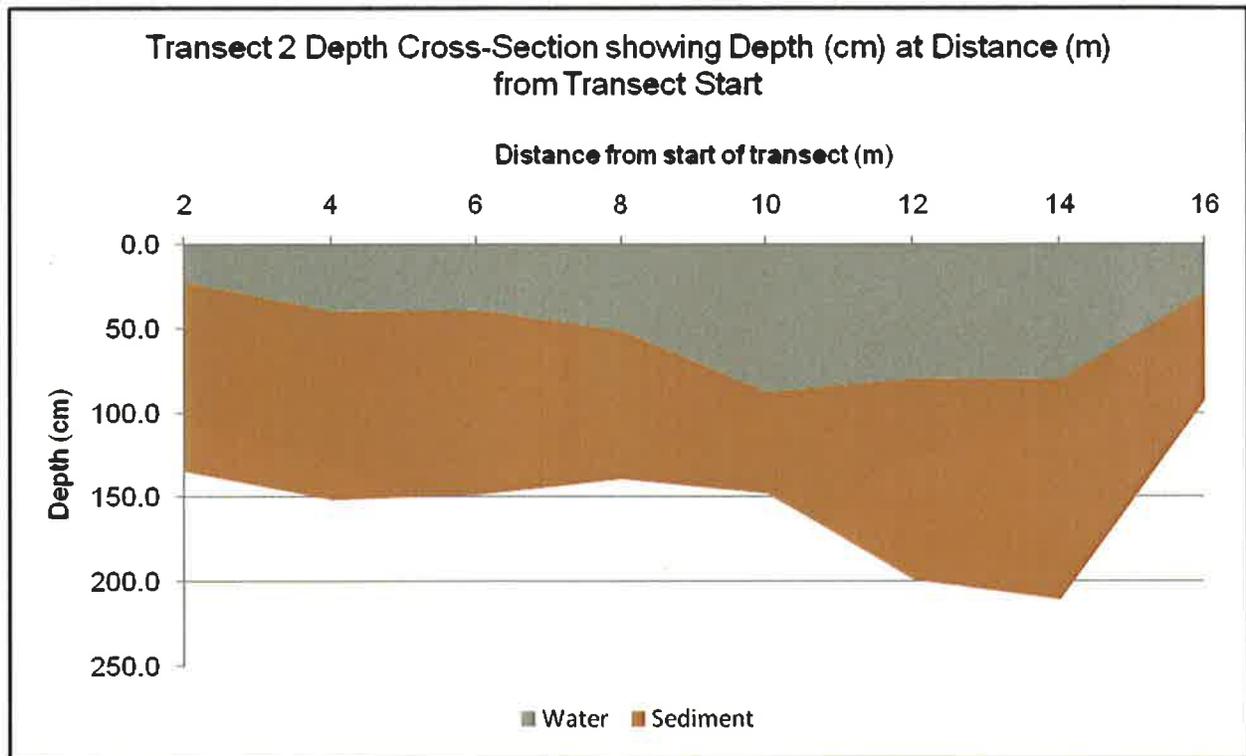
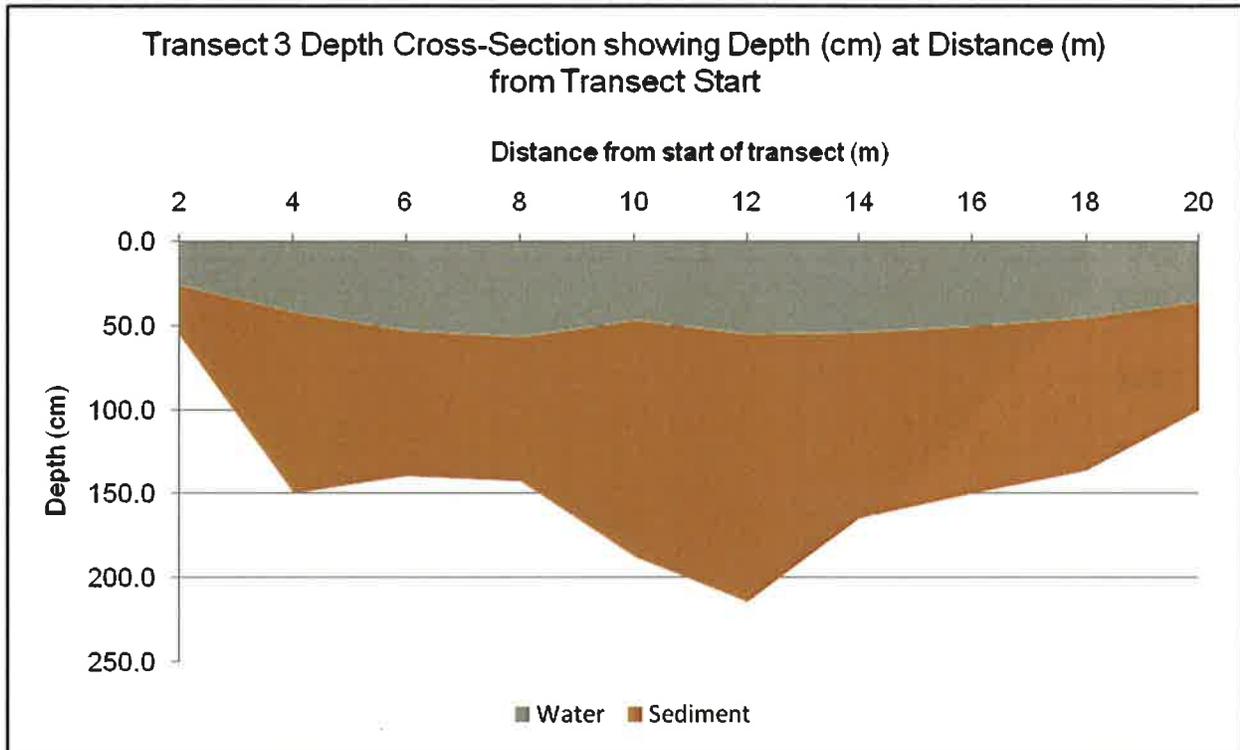
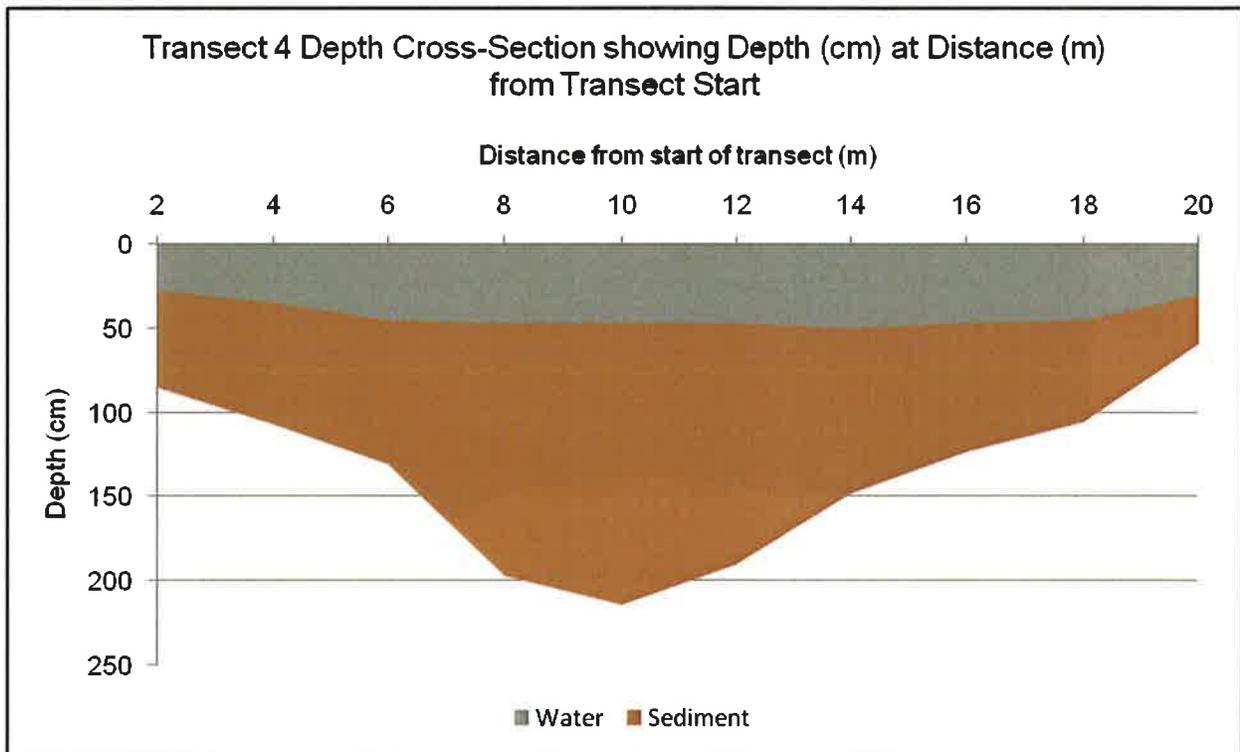
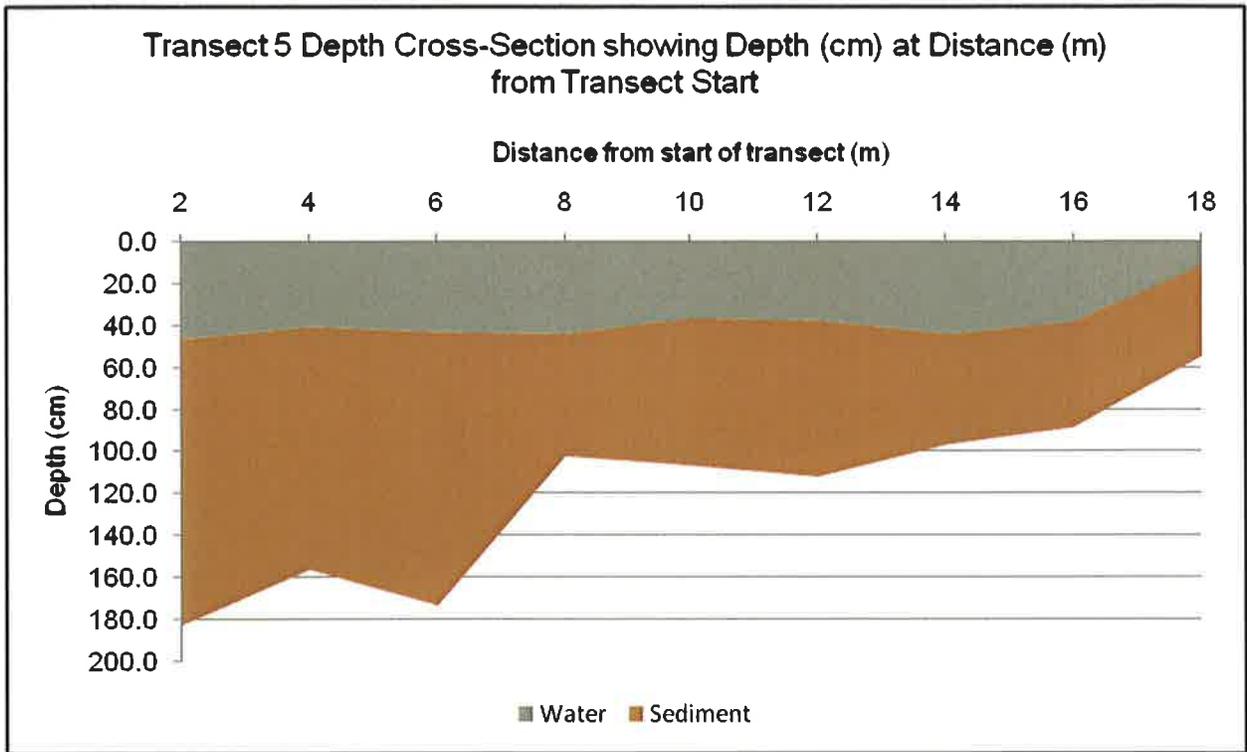
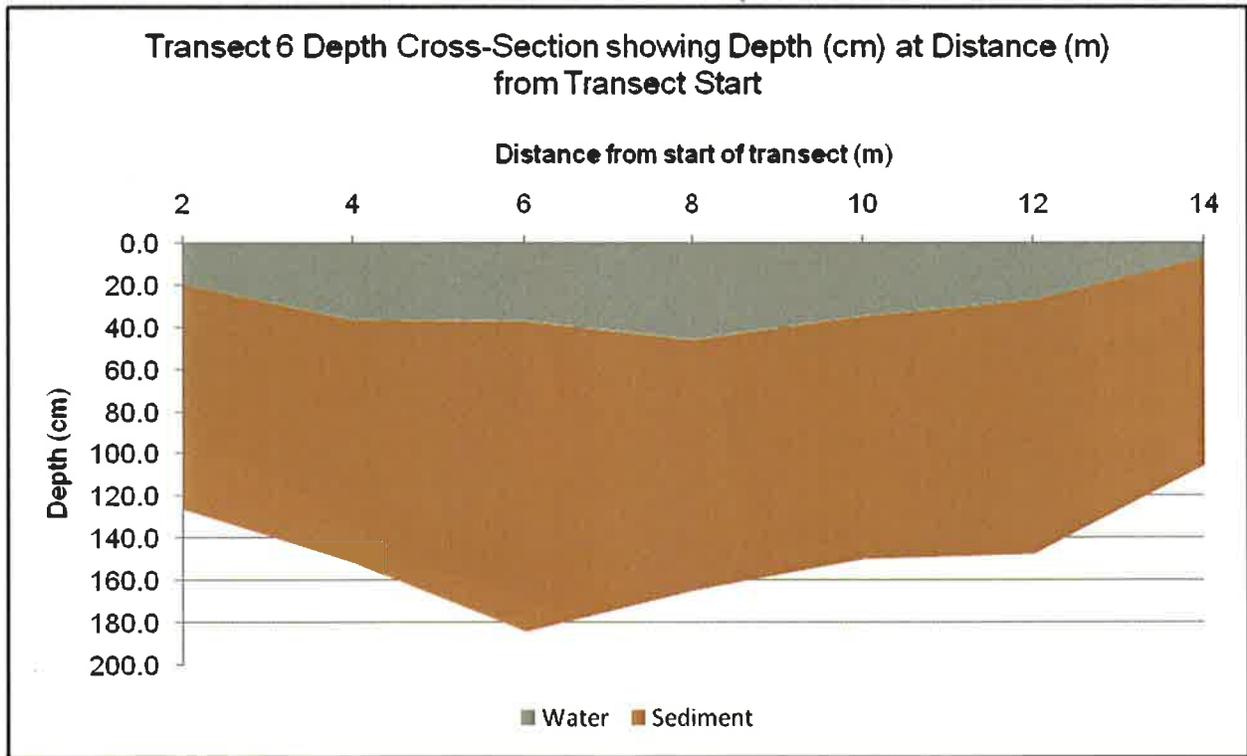
Figure A-1 – Depth cross-section: depth (cm) at distance (m) from transect start for transect 1

Figure A-2 – Depth cross-section: depth (cm) at distance (m) from transect start for transect 2

Figure A-3 – Depth cross-section: depth (cm) at distance (m) from transect start for transect 3

Figure A-4 – Depth cross-section: depth (cm) at distance (m) from transect start for transect 4

Figure A-5 – Depth cross-section: depth (cm) at distance (m) from transect start for transect 5

Figure A-6 – Depth cross-section: depth (cm) at distance (m) from transect start for transect 6

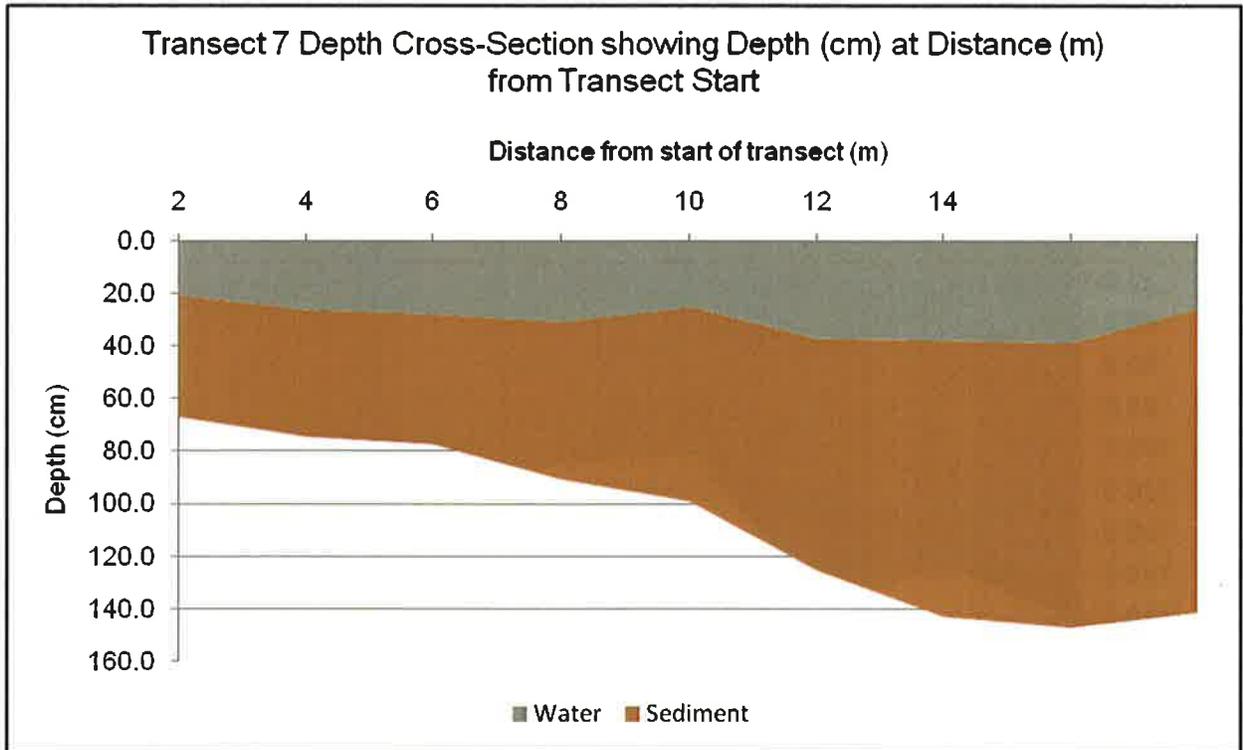
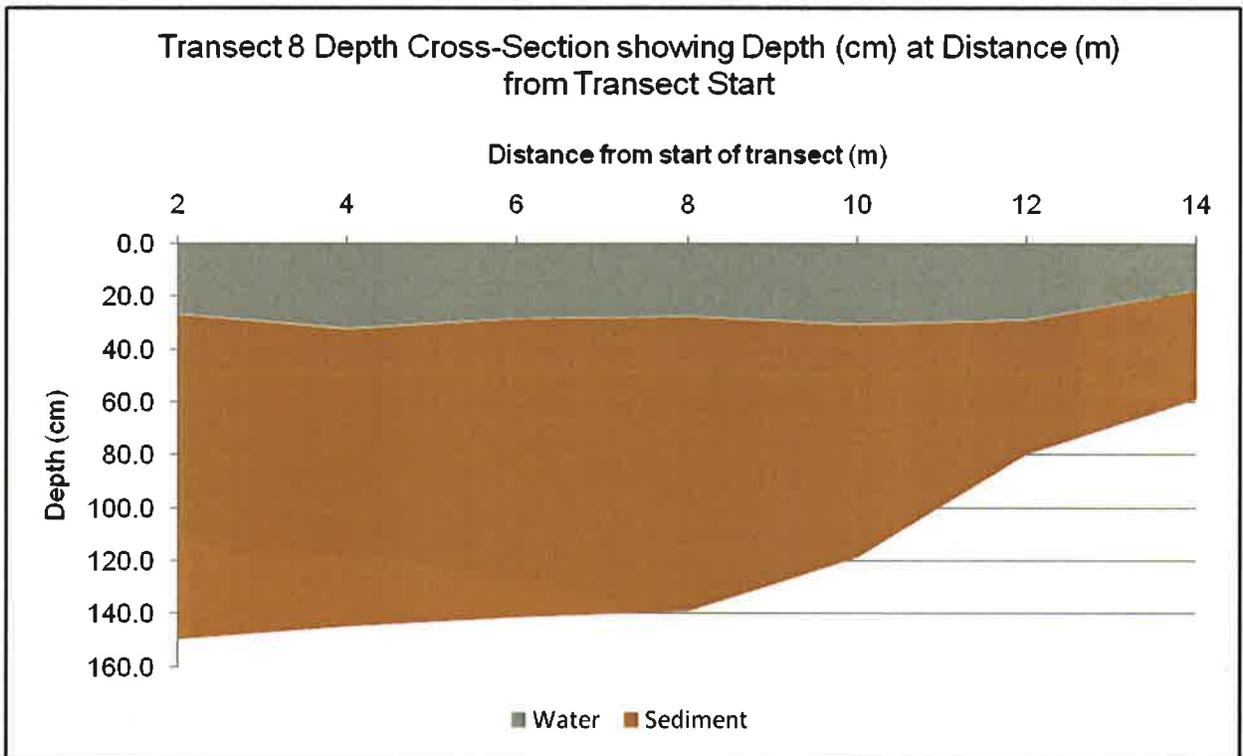
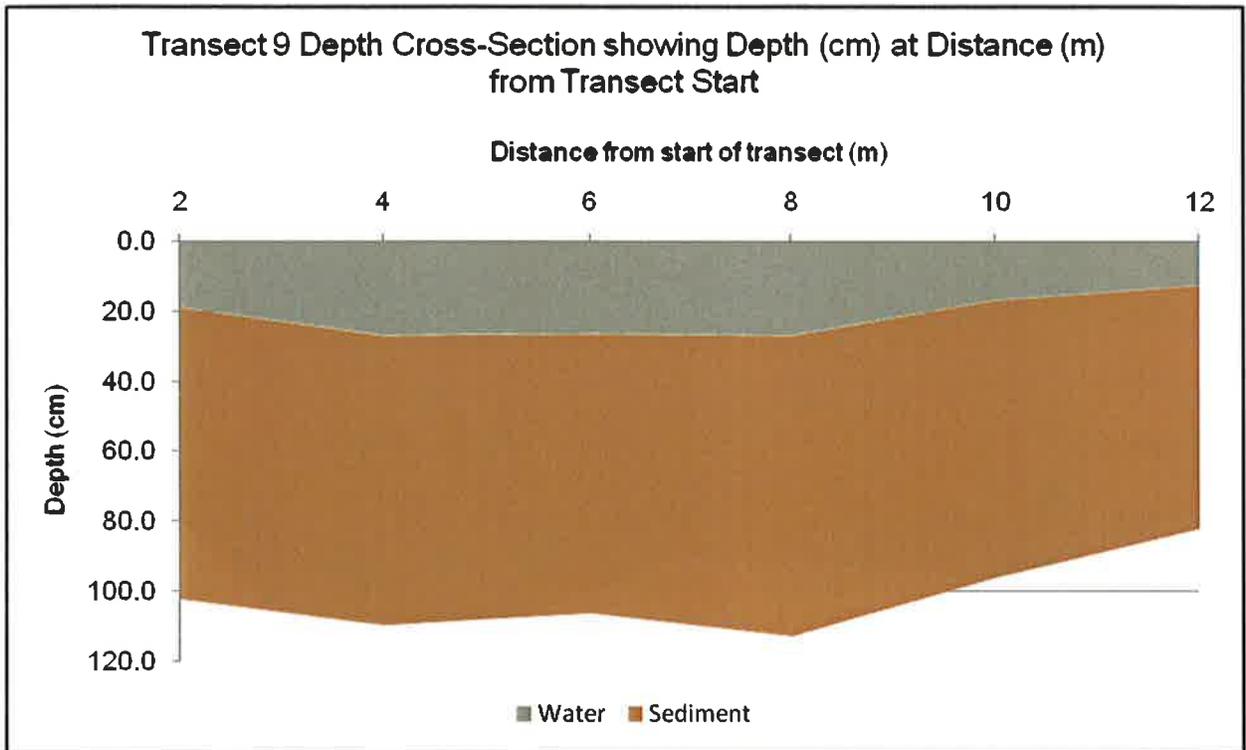
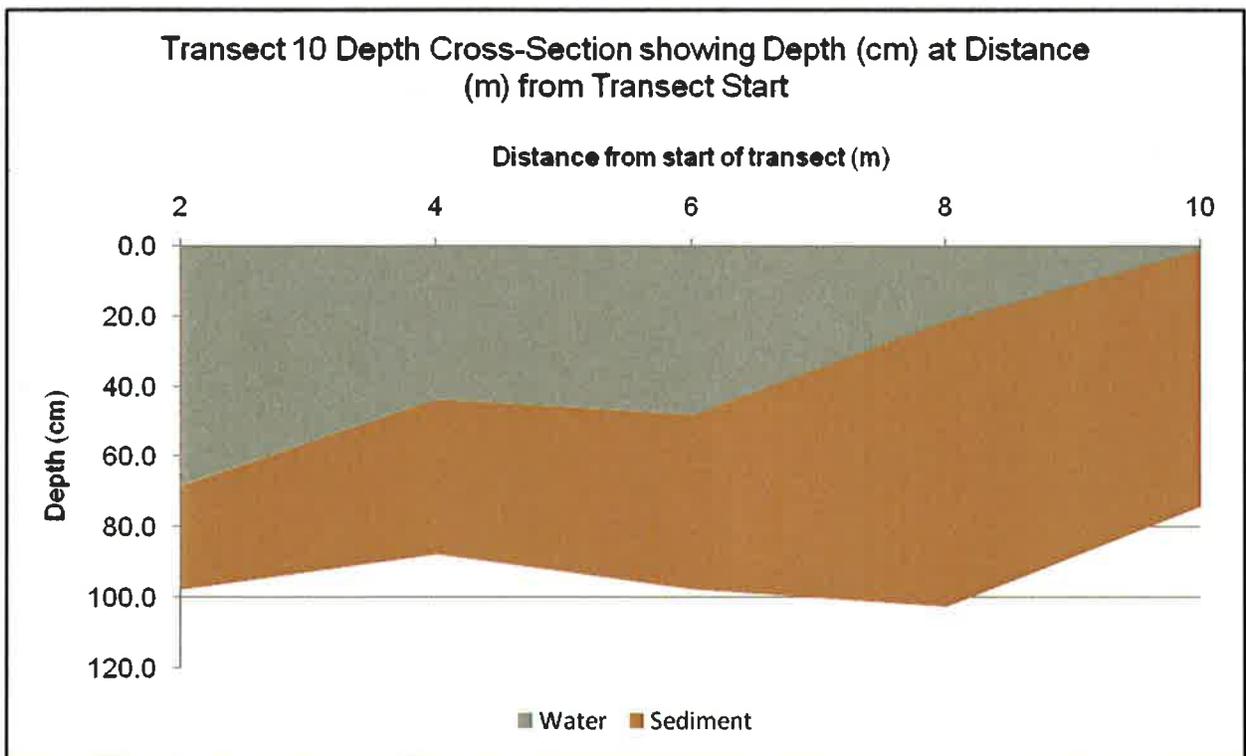
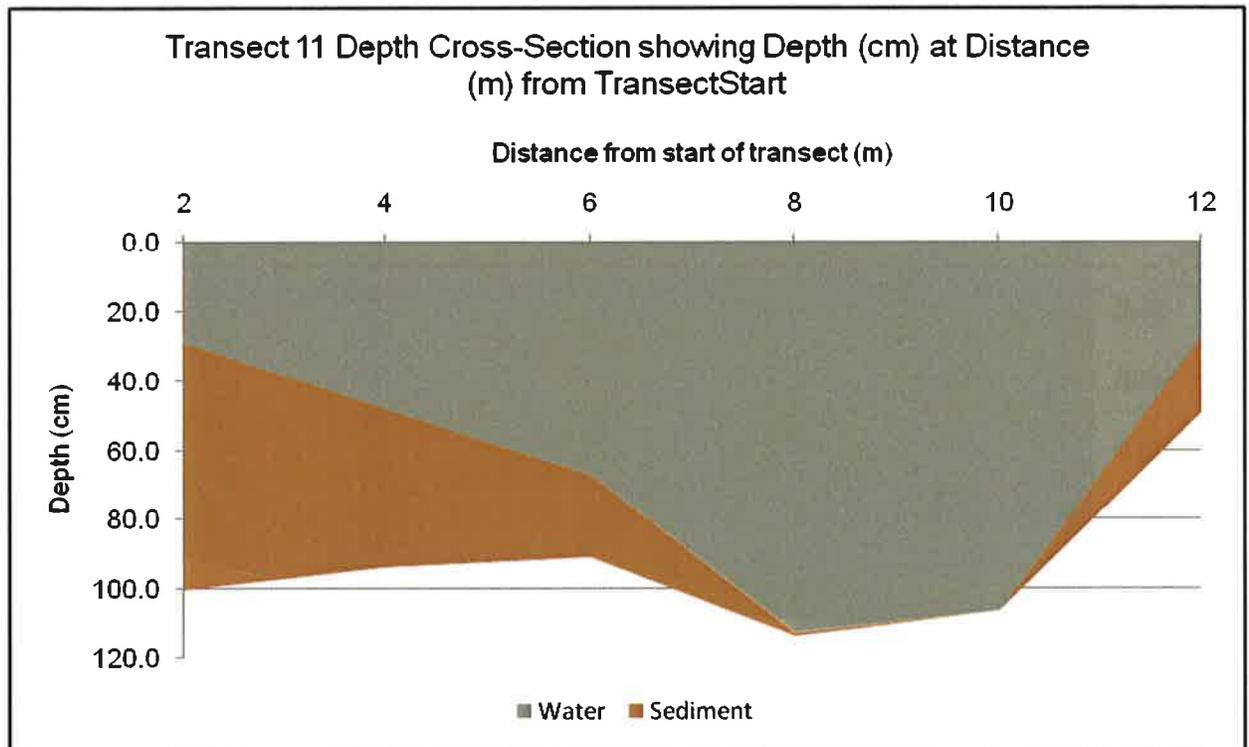
Figure A-7 – Depth cross-section: depth (cm) at distance (m) from transect start for transect 7

Figure A-8 – Depth cross-section: depth (cm) at distance (m) from transect start for transect 8

Figure A-9 – Depth cross-section: depth (cm) at distance (m) from transect start for transect 9

Figure A-10 – Depth cross-section: depth (cm) at distance (m) from transect start for transect 10

Figure A-11 – Depth cross-section: depth (cm) at distance (m) from transect start for transect 10

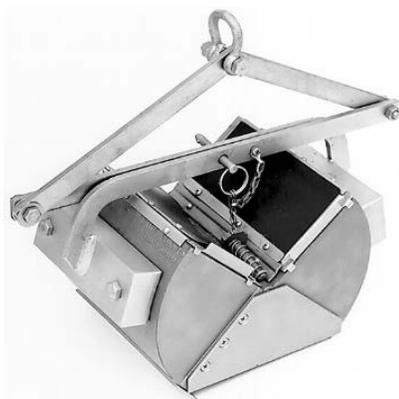
Petite Ponar Grab Sampler

Both surface grab samples and core samples were collected depending on location and expected depth of sediment. Core samples collected so that both shallow (i.e., more recently deposited) and deeper (i.e., older deposit) sediments could be represented. Surface grab samples were collected using a stainless steel Petite Ponar Sampler that is widely used in both fresh and salt water for sediment sampling including from hard bottoms such as sand, gravel, consolidated marl or clay. Core samples were collected using a Wildco stainless steel corer with enclosed ~5 cm (~2 in) sleeve inside the stainless steel sheath attached to the threaded head assembly. Both Petite Ponar and Wildco core sampler were dropped for sampling and retrieved manually using a rope securely attached to each. Figure B illustrates the samplers.

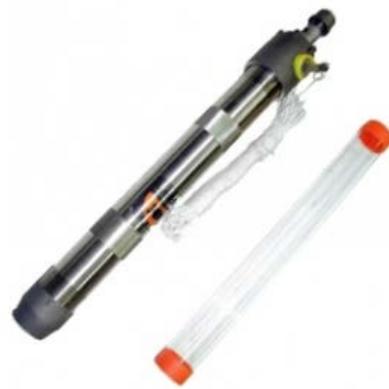
Wildco Stainless Steel Core Sampler

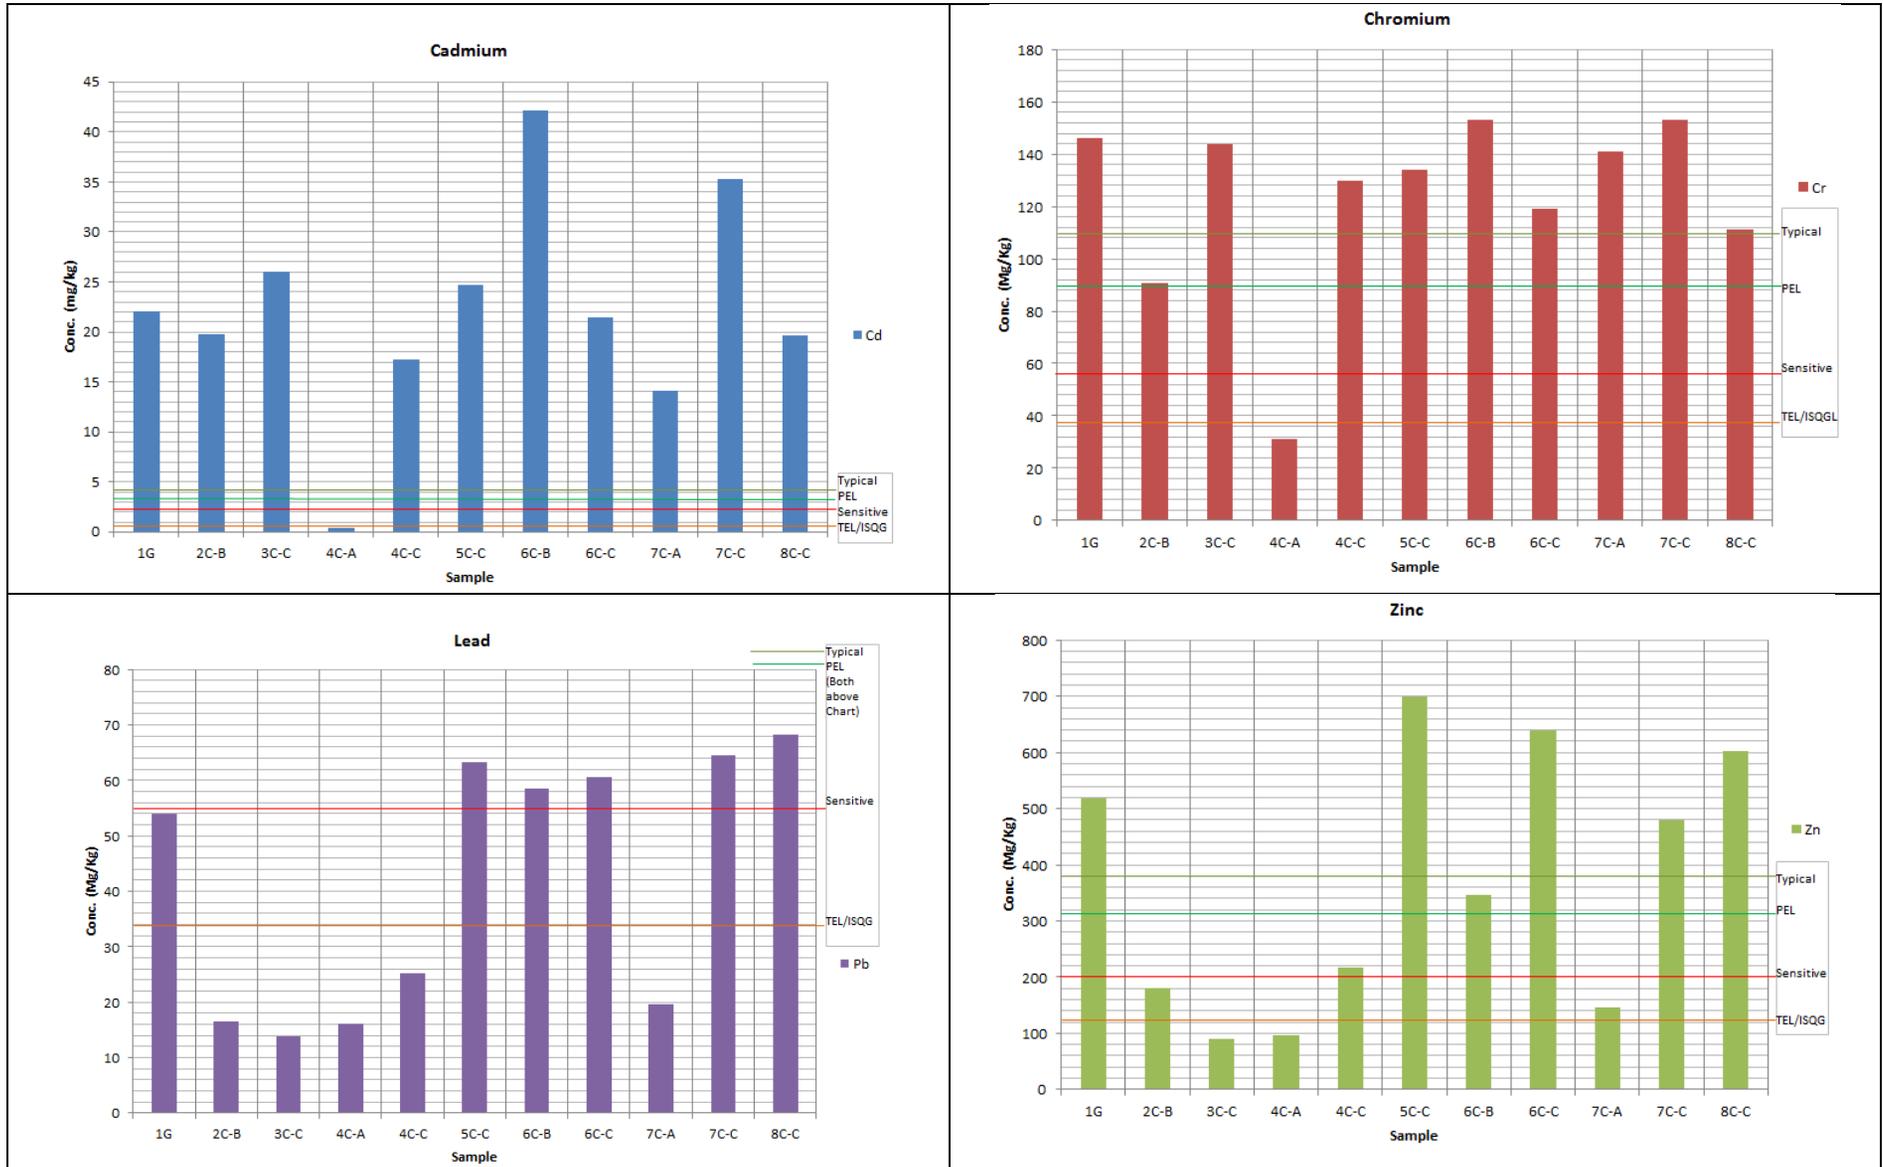
Figure C
Metal Concentrations (Cd, Cr, Pb & Zn) in Relation to CSR Criteria & CCME Guidelines

Figure C below illustrates the range of concentrations of the four metals noted above and the criteria / guidelines.

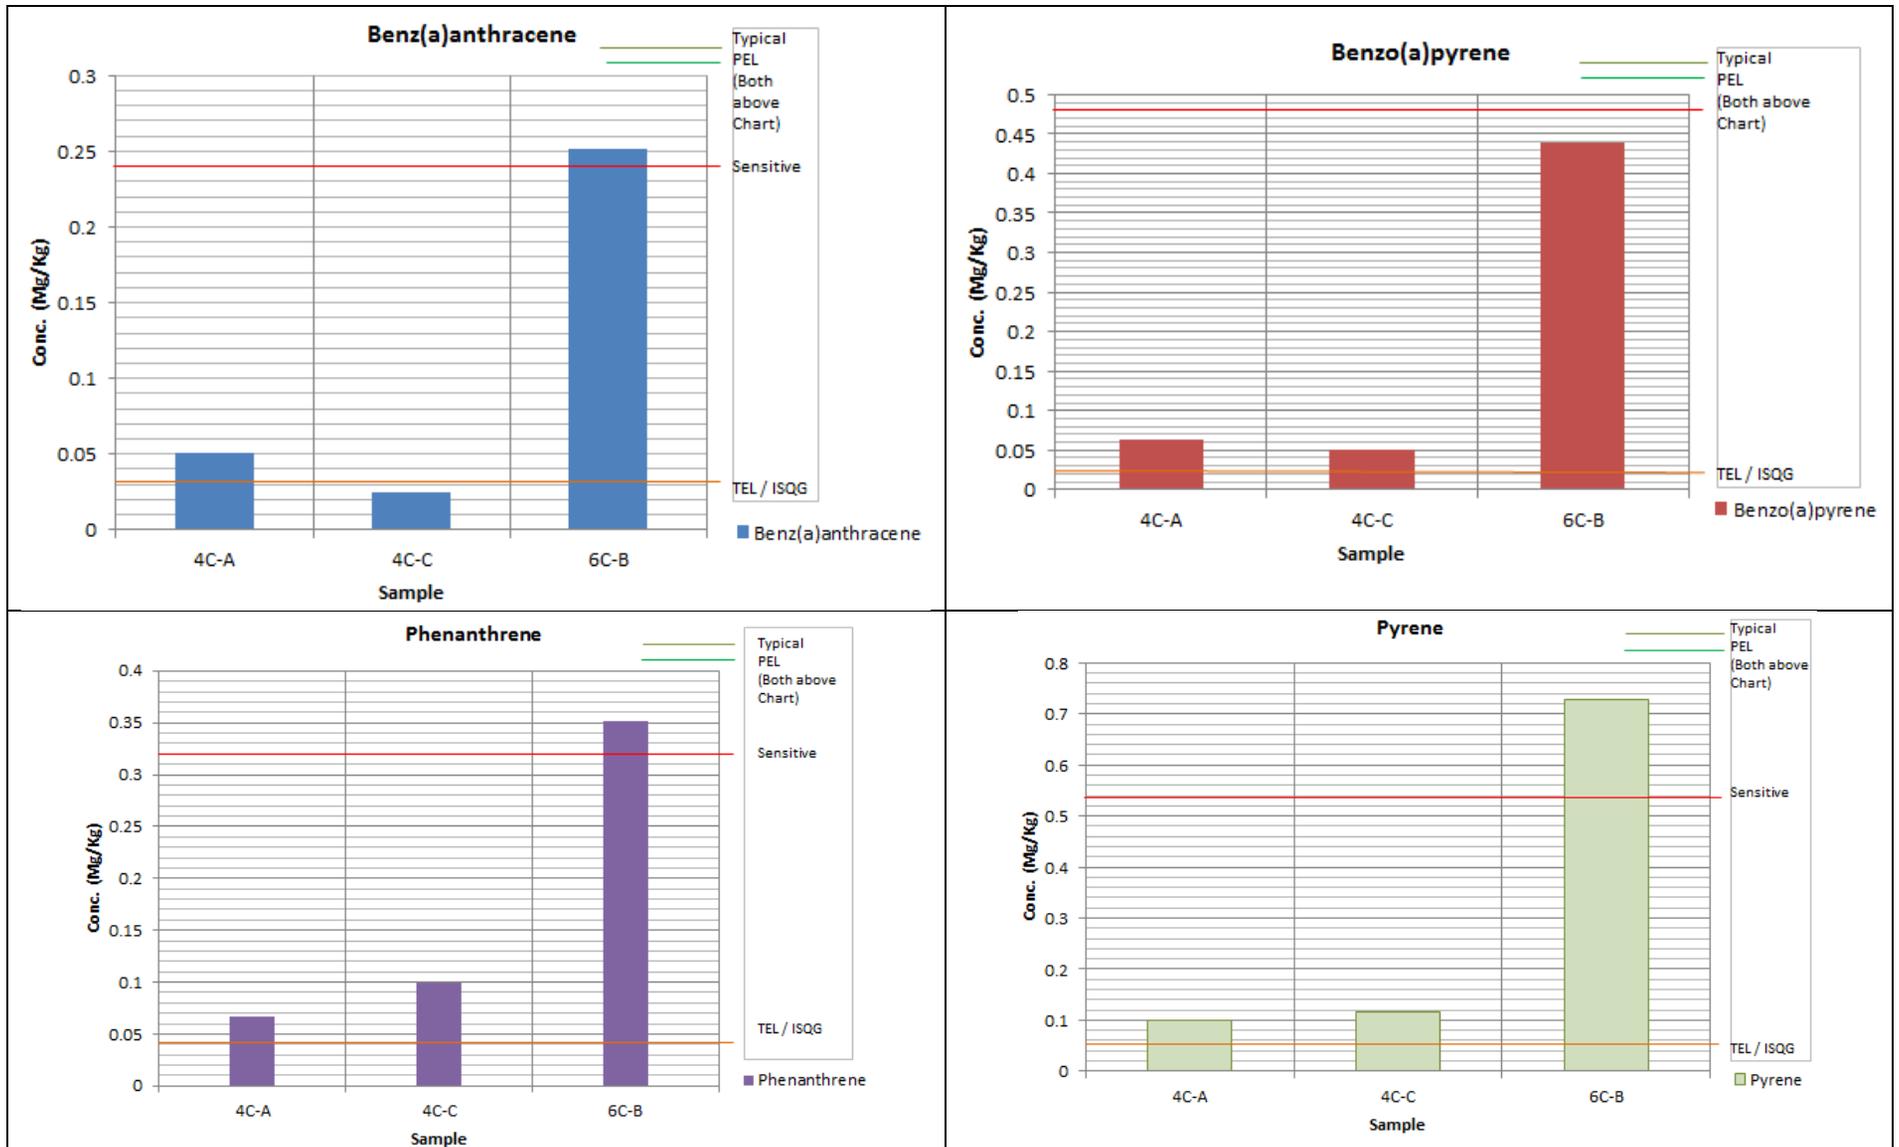
Figure D
Concentrations of Selected PAHs in Relation to CSR Criteria & CCME Guidelines

Figure D below illustrates the concentrations of four selected PAH substances that had concentrations exceeding one or more published criteria / guidelines. This sample with the highest concentration of a number of the PAHs was for a mid-depth sample (i.e., indicated by the XX-B label vs. the surface sample (XX-C) or the deeper (XX-A) sample).

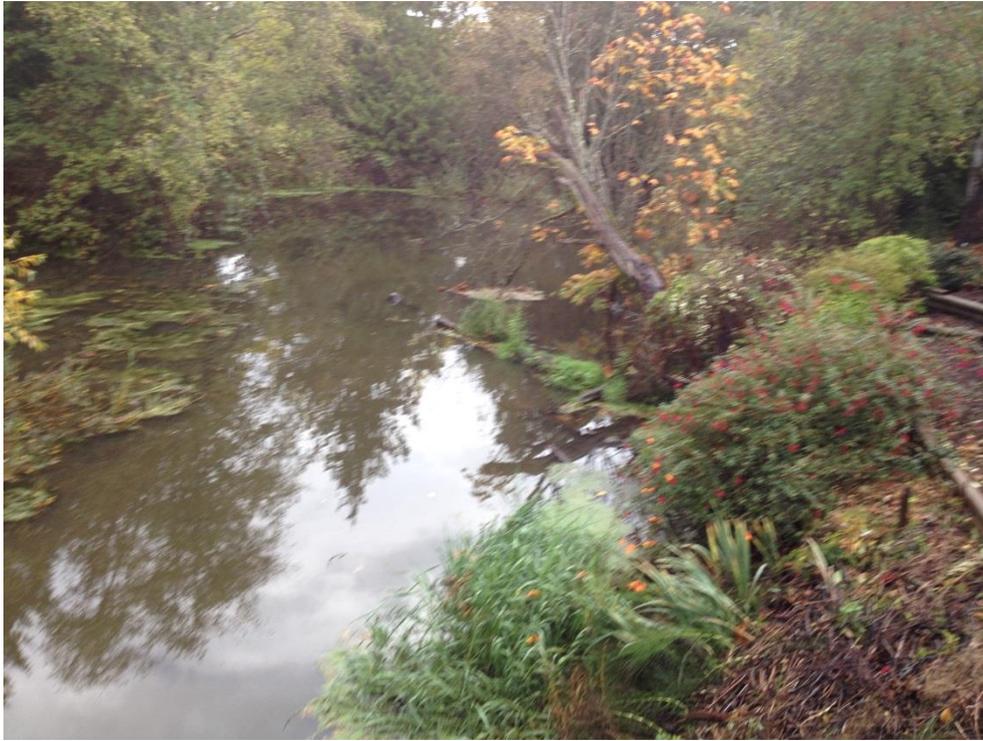
Photo 1: Reay Cr. Pond viewed to the southeast towards the area of the dam, from approximate mid-pond area, Oct. 22, 2014

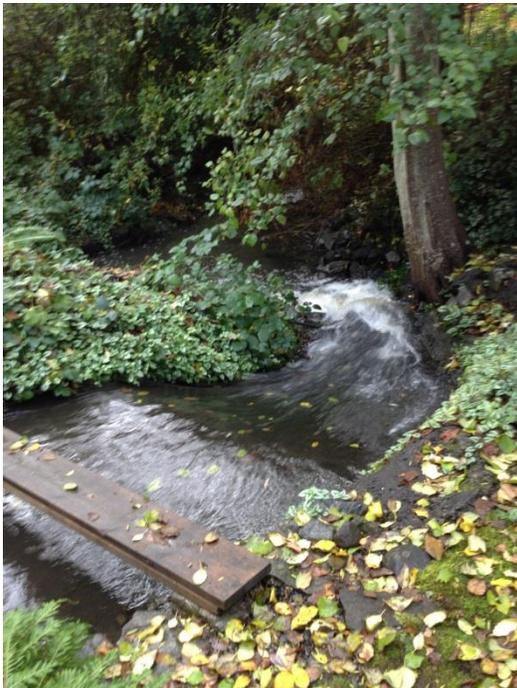
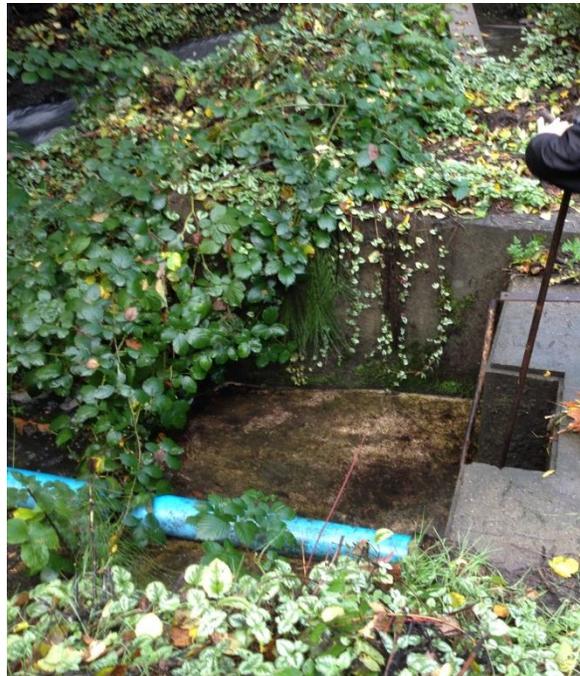
Photo 4: Pond discharge over dam spillway (left & top of right photo) and valve controlled discharge pipe at dam

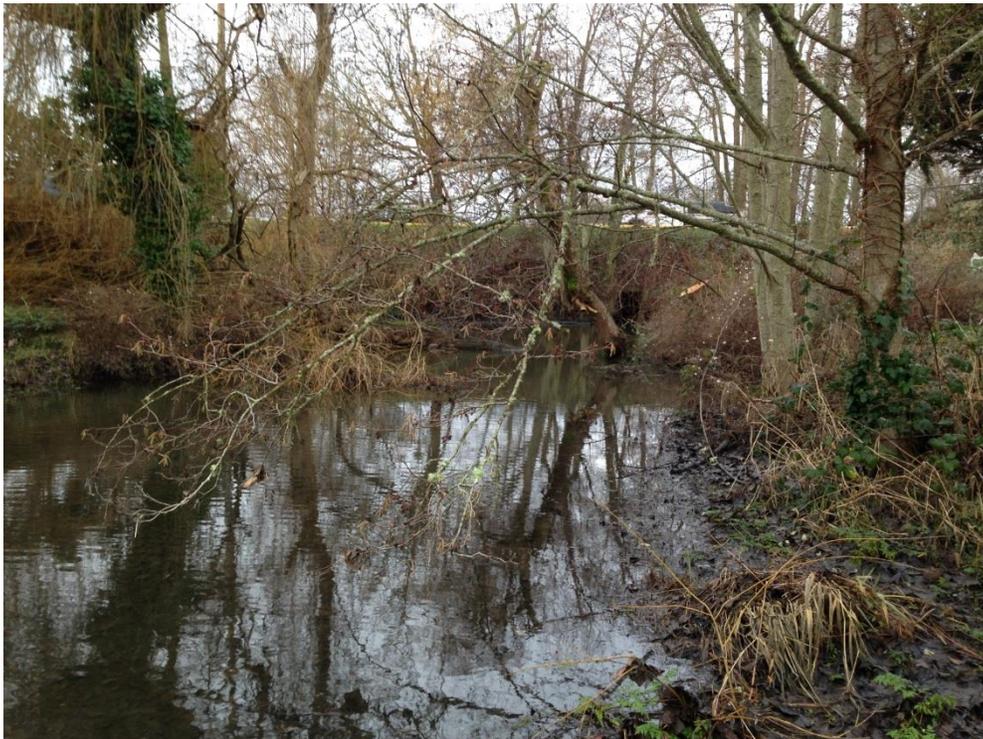
Photo 6: Pond area narrowed by vegetation, viewed northeast from approximate mid-pond

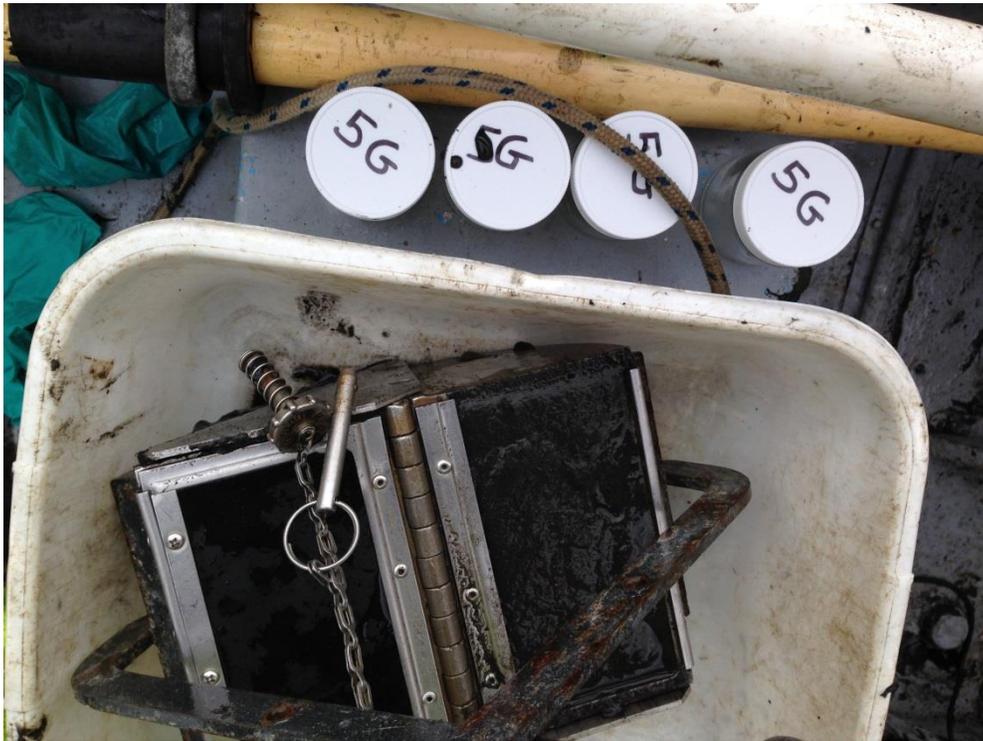
Photo 7: Petite Ponar (top) sampler used for surface sediment grab sampling

- Sediment sampling was carried out using either petite ponar or wildco stainless steel corer;
- Locations were selected to represent sediments over full length of the Pond;
- Used lab-supplied sampling jars and cross-contamination prevention measures;
- Some organics (twigs, decomposed leaves, etc.) limited sample collection to 10 centimetres (cm) in some areas;
- Ponar samples represented top 10 cm of sediment;
- Core samples represented surface (0-8 cm or 0-10 cm); mid-core (8-30 cm); deeper (25-40 cm);
- Samples were analyzed for PAH and metals content;

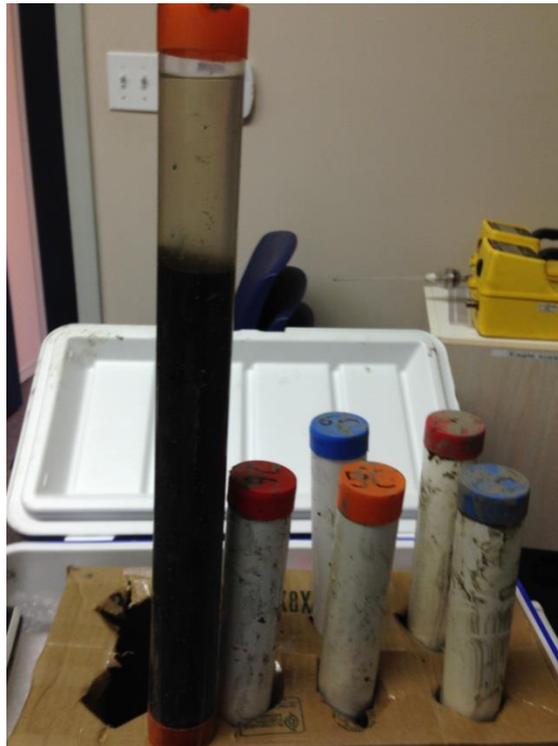
Photo 8: Sediment core samples in capped tubes ready for extruding and sampling

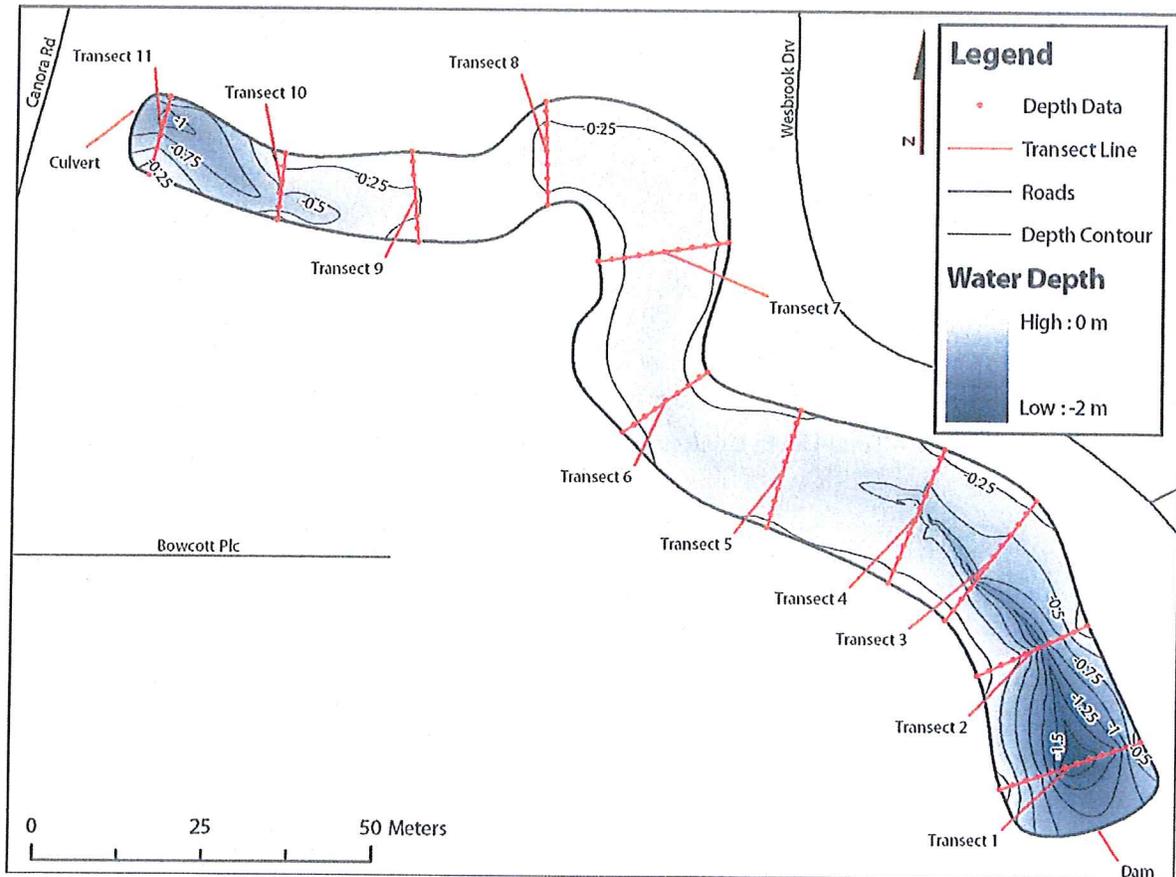
Figure 3 – Water Depth Contour Map of Reay Creek Pond, June 2010

Two maps were produced using the collected depth data (Table 1 of Appendix A). Figure 3 shows the depth of water and Figure 4 shows the depth of sediment in Reay Creek Pond. A third map (Figure 5) was produced to show the thickness of sediment.

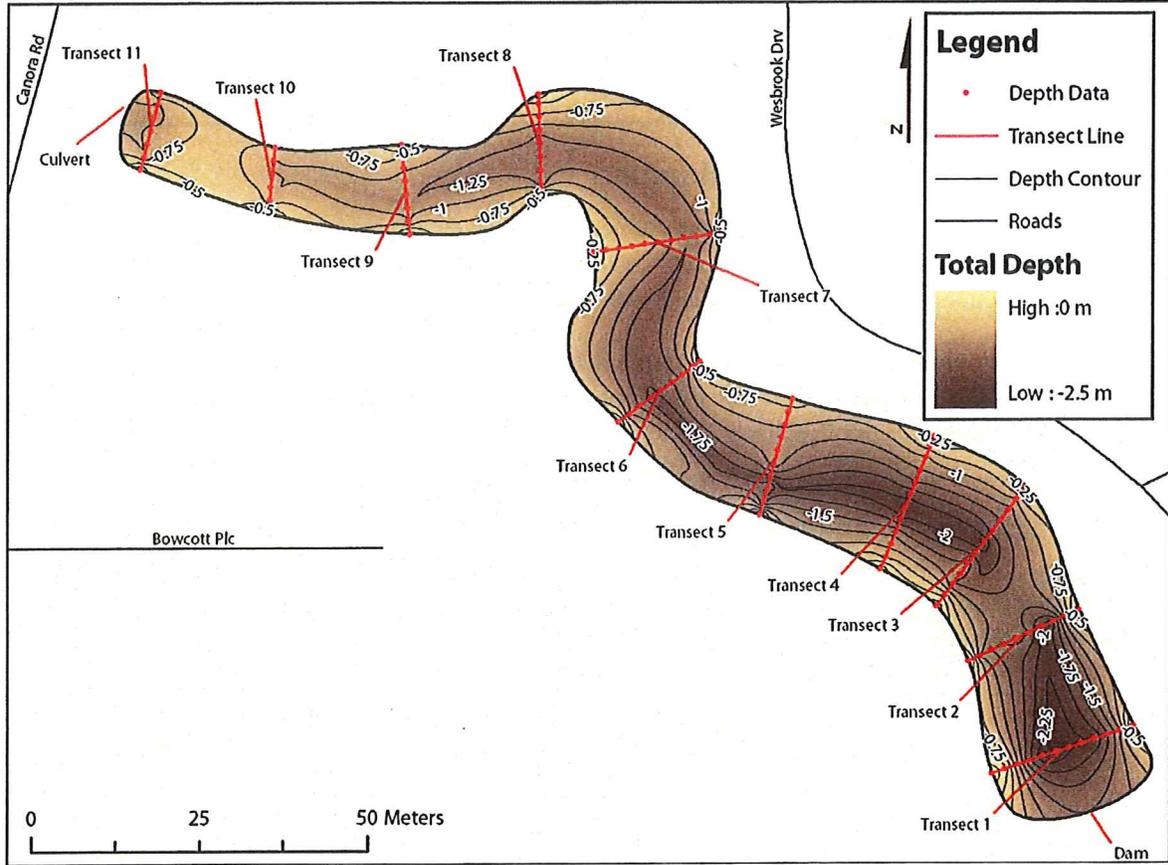
Figure 4 – Total Depth Contour Map of Reay Creek Pond, June 2010
