**Data Gap Analysis Reay Creek Pond
Canora Road Between Northbrook Drive and Bowcott Place, Sidney, BC**

**May 2016
SLR Project No.: 201.02016.00001**

The Reay Creek Technical Working Group and the Town of Sidney required a review and interpretation of sediment investigation results collected since 2010, with a view to examine the need for, and feasibility of, future remediation and/or restoration of Reay Creek Pond.

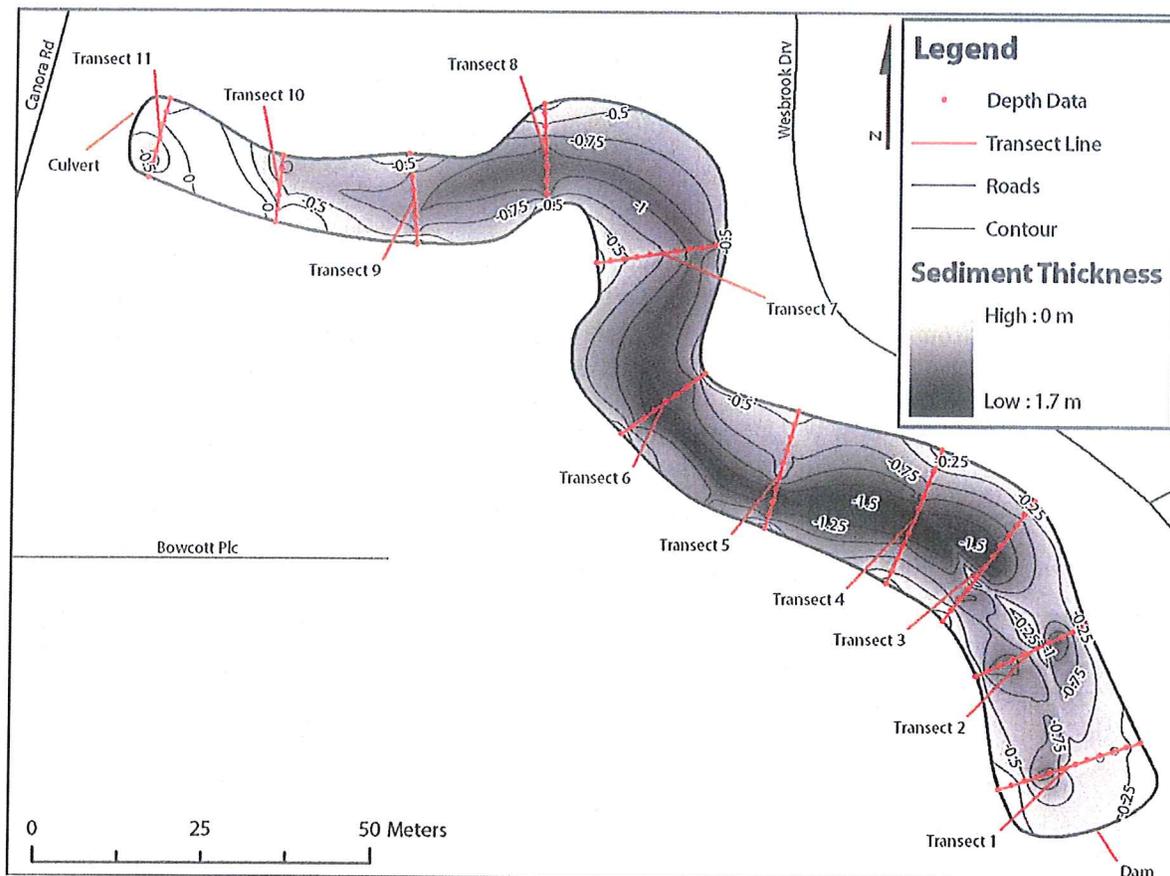
Figure 5 – Thickness of Sediment and Contours Map of Reay Creek Pond, June 2010

Two maps were produced using the collected depth data (Table 1 of Appendix A). Figure 3 shows the depth of water and Figure 4 shows the depth of sediment in Reay Creek Pond. A third map (Figure 5) was produced to show the thickness of sediment.

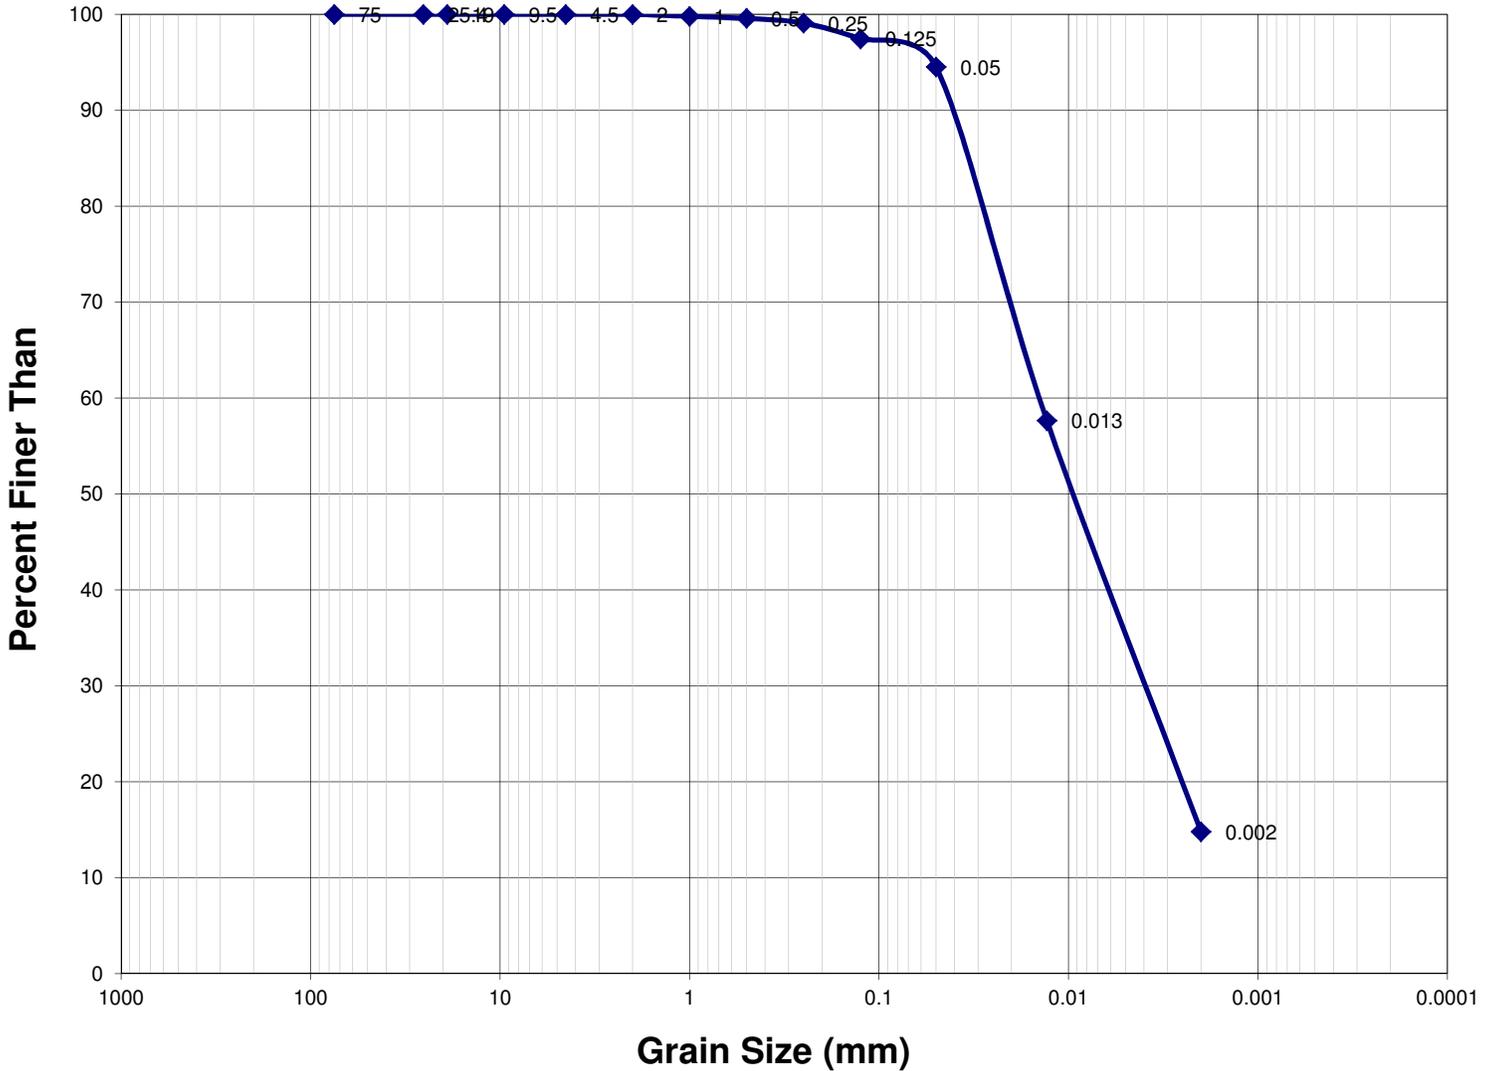
Particle Size Distribution Curve

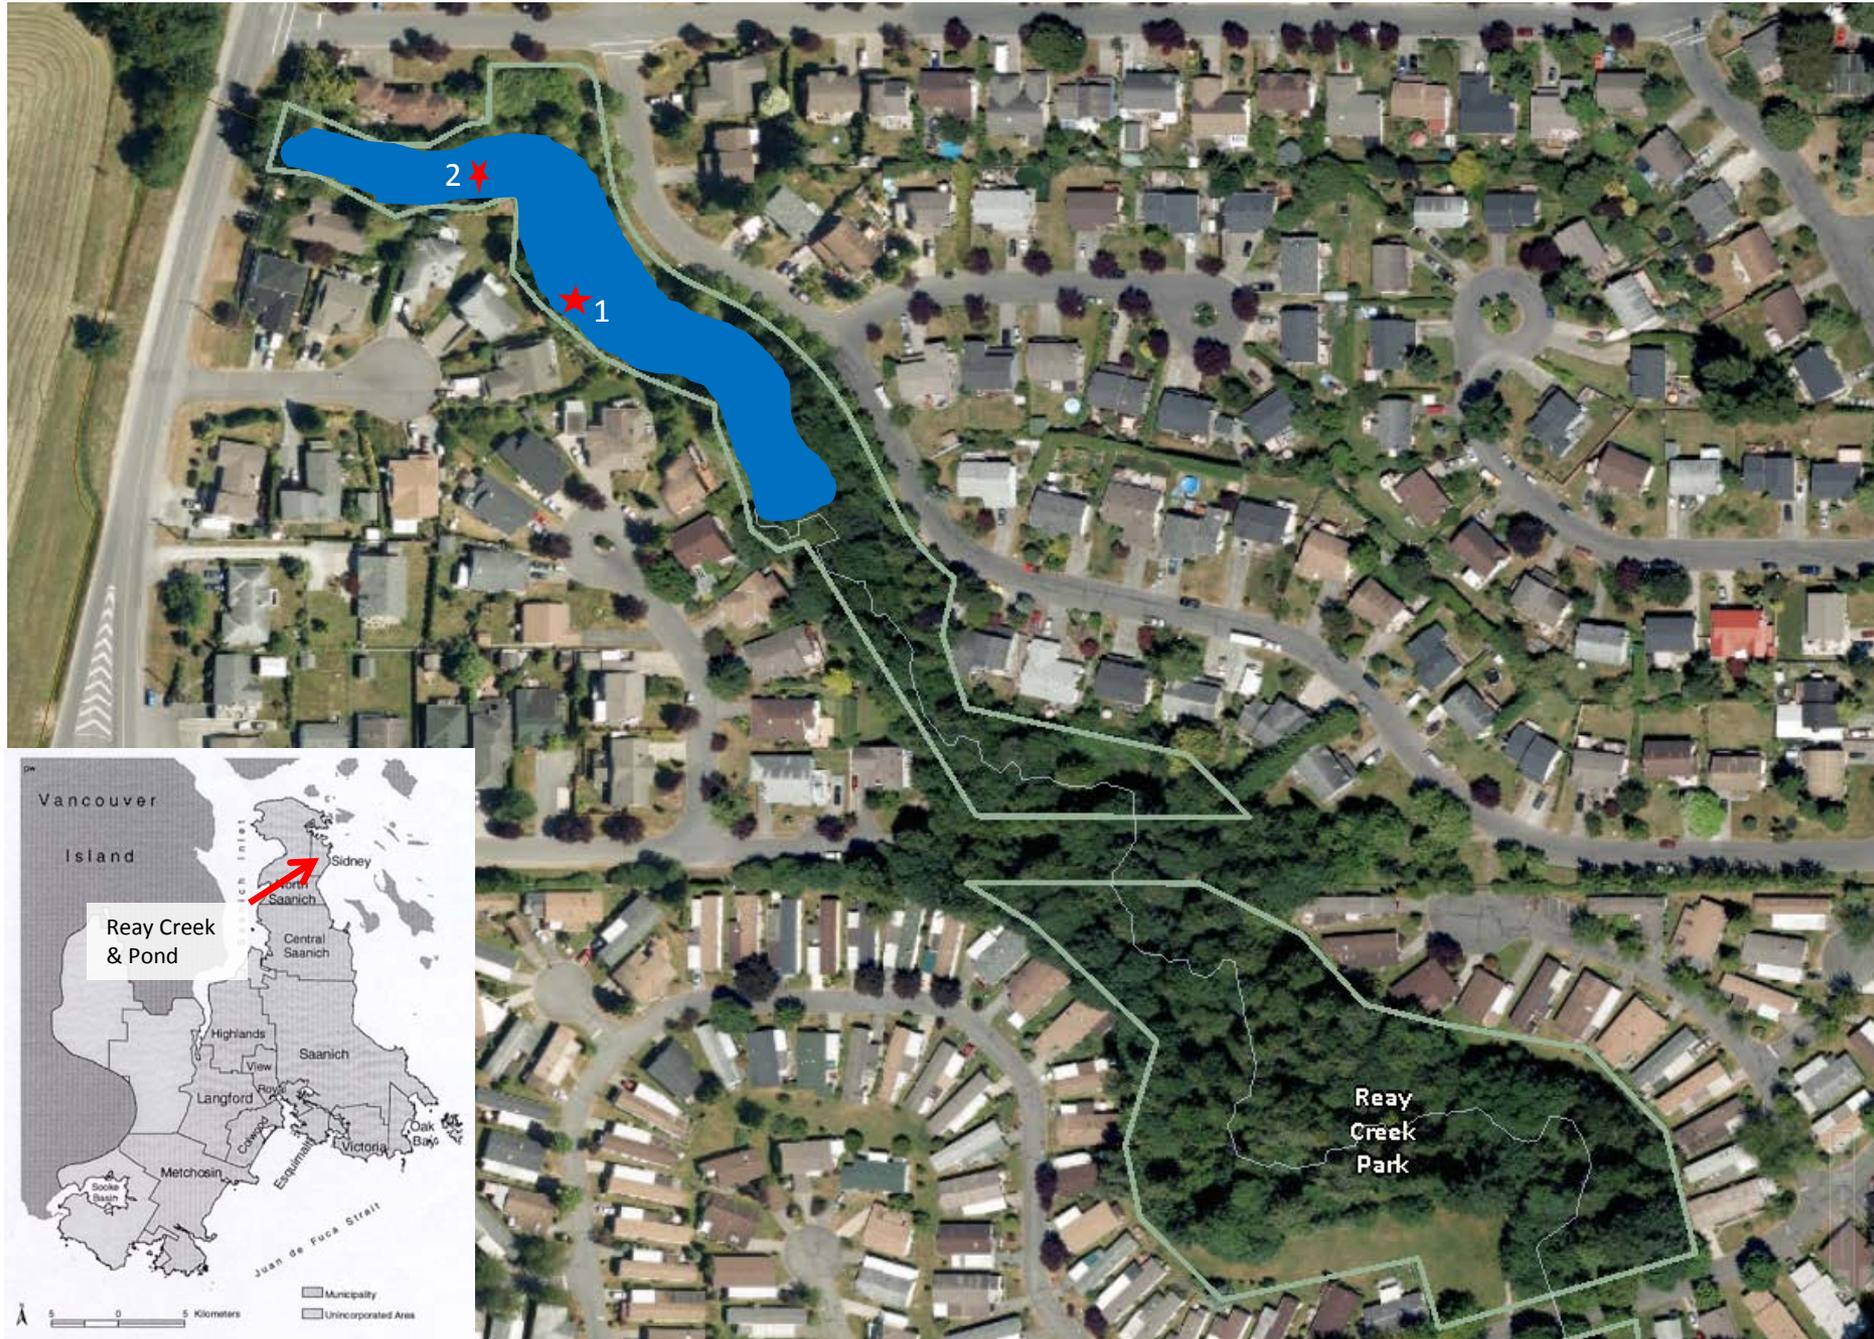
Figure 2. Plan view of Reay Creek Pond showing locations of Cores (2013), Original Dam (~1935) and transects and sampling points at which water and sediment depth were determined in 2010 (Robinson and Sarrazin, 2010).

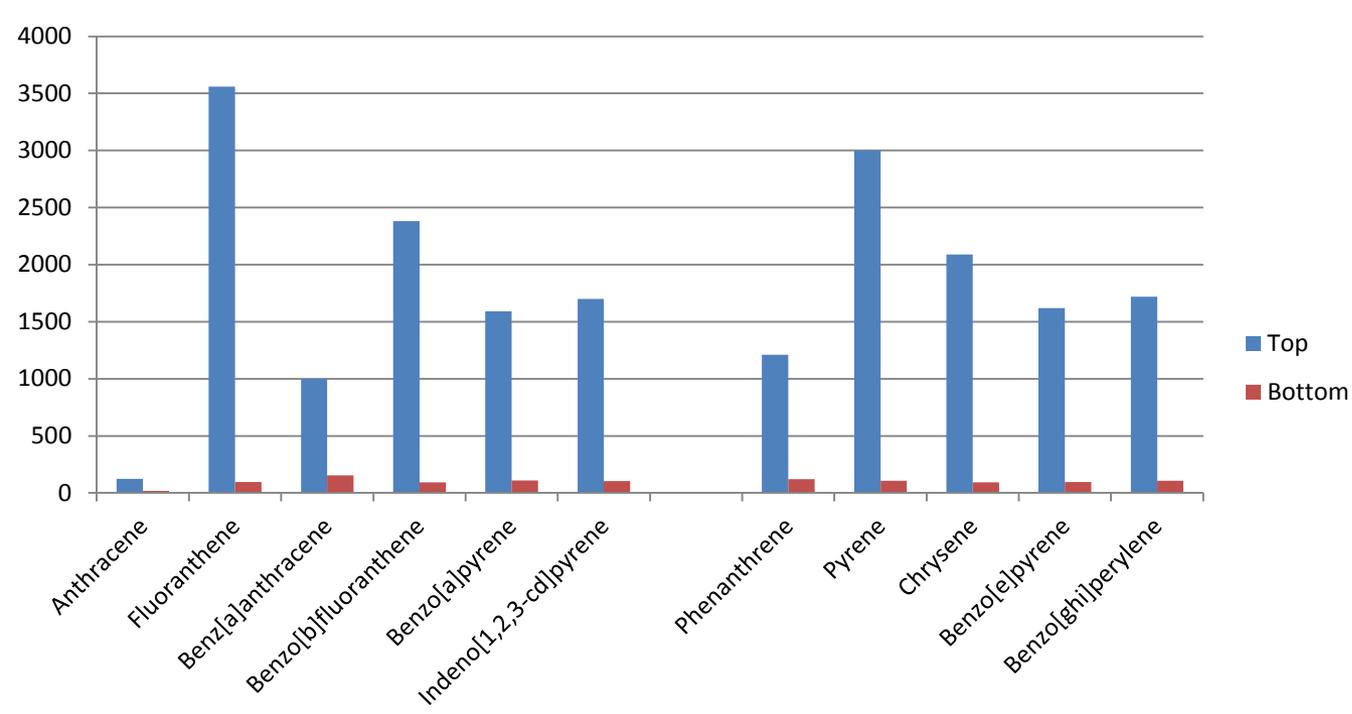
Less stable ones to left, more stable to right. I think we have a mix of sources including combustion and petrogenic, but more work would need to be done to sort it out. I suspect that a lot of these PAHs are coming from somewhere other than combustion – like use of creosote etc.

Figure 9. DDT compounds measured in the pooled sediment samples (top and bottom).
