Town Of Sidney Municipal Building Building Assessment Report

Project Number:
2025508

Prepared By:
Number Ten Architectural Group
200-1619 Store Street
Victoria BC V8W 3K3

Date:
2025-06-03

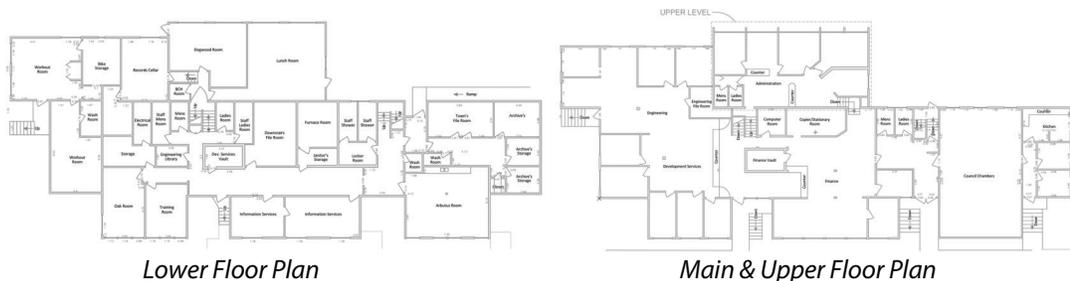
The existing building circulation is extremely poor due to the multiple levels resulting from the addition to the original. To meet the current code all area's of the building would need to be accessible to a wheel chair. Currently exterior ramping provides access to significant portion of the building but to move from one level to another involves leaving the building and re-entering. This meets a bare minimum for public access, to the front desk and council chambers, but is not acceptable for disabled staff and excludes them completely from a significant portion of the building. An elevator could potentially be installed with 4 stops at half levels, opening both sides to provide access to all floors. This would need to be combined with a reworking of the 1st floor (partial basement) to access the area's with only external access.

The accessibility issue is compounded by narrow halls in several locations which would need to be reconfigured. All the above work would require costly structural work to reconfigure. The final result would be functional and meet code but be less than ideal in terms of easy circulation. Several storage area's throughout the building are completely inaccessible and would need to be increased in size.

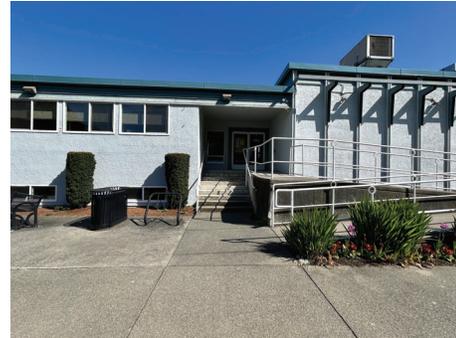
Accessible washrooms are only provided outside the council chambers. These would need to be provided on every floor as part of a significant renovation. In addition to reworking of corridors as noted above, a number of doors would require realignment or auto openers to be fully accessible. The main entry door would require an operator regardless.

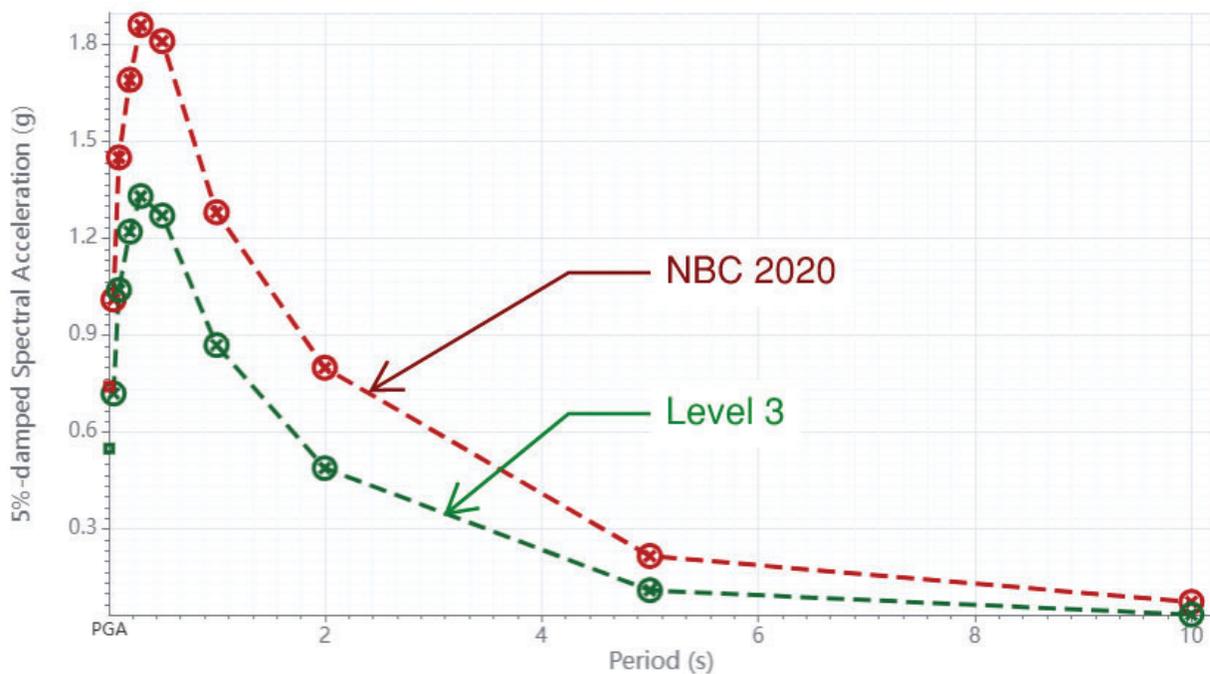
Figure 2: Seismic Hazard

If this structure were to be renovated, it would be classified as a "Major Renovation" and the minimum recommended upgrading should be to "Level 3", which for this project roughly equates to 67% of the NBC 2020 seismic force level (refer to Appendix A for excerpt from Commentary L). Figure 2 below illustrates the proposed upgrade force level (Level 3 per Commentary L) in relation to the NBC 2020 full code values.

Based on our analysis, the existing lateral load resisting system does not have sufficient capacity and can only resist approximately 30% of Level 3 Seismic Force Levels (or 20% of NBC 2020 seismic force levels). The critical elements appear to be the wood frame exterior walls and diaphragm connections to these exterior walls. In addition, the foundations have not been sized to resist the compression or uplift requirements of exterior shear walls if they were upgraded.
